GEO-HAZARDS DURING EARTHQUAKES AND MITIGATION MEASURES

-LESSONS AND RECOMMENDATIONS FROM THE 2011 GREAT EAST JAPAN EARTHQUAKE-

The Japanese Geotechnical Society

July 2011

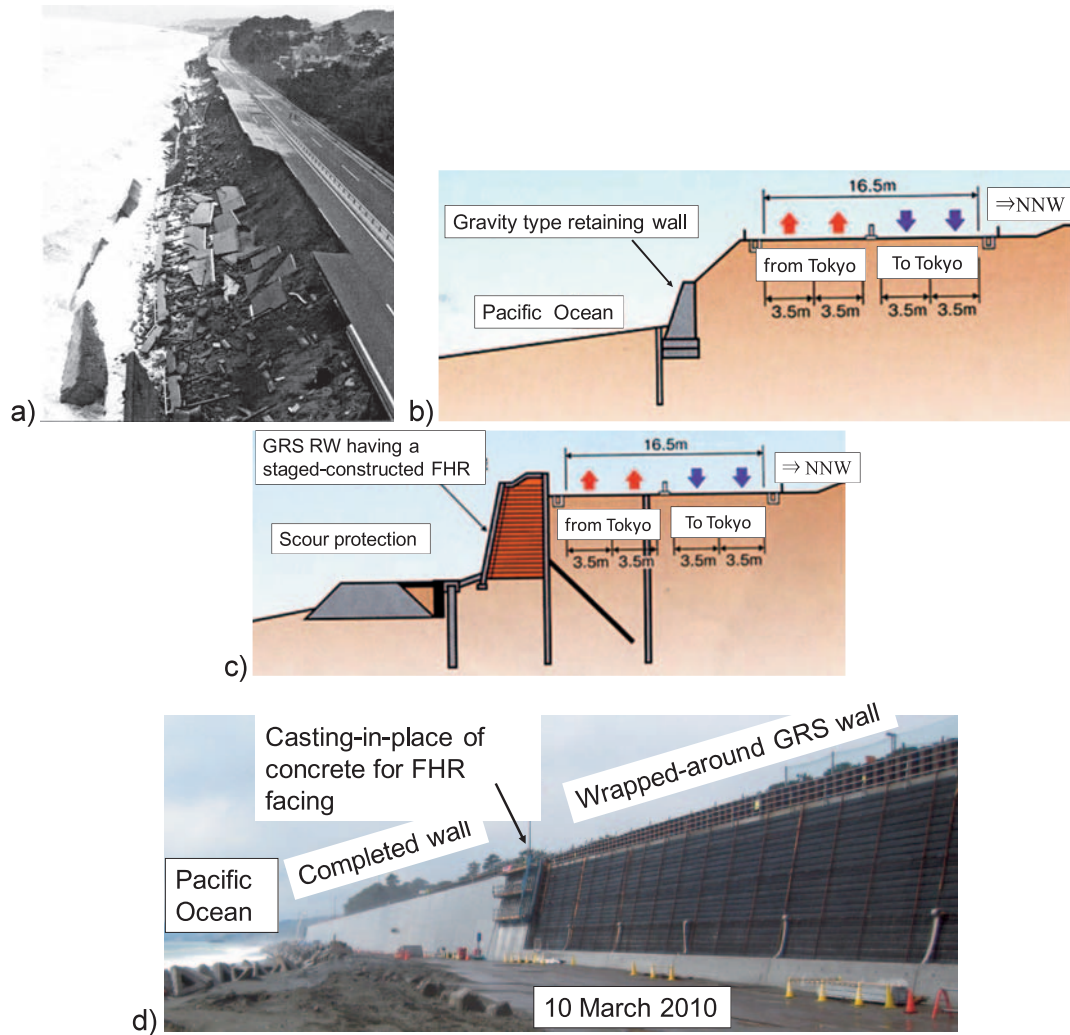
Fig. 2-7 Seawall of Seisho by-pass for National Road No. 1 in Kanagawa Prefecture, southwest of Tokyo: a) collapse for a length of about 1 km by Typhoon No. 9, 29th Aug. 2007; b) original structure; c) reconstructed seawall; and d) the wall during construction (a), b) & c): by the courtesy of the Ministry of Land, Infrastructure, Transport and Tourism; and d) by Tatsuoka, F.)

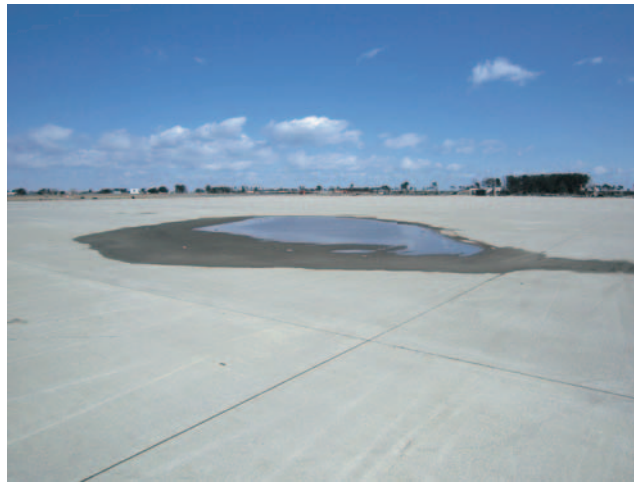
Fig. 3-2 Settlement of the apron at the Sendai airport due to soil liquefaction in the area where countermeasure against soil liquefaction had not been taken (by the courtesy of PARI, Port and Airport Research Institute)

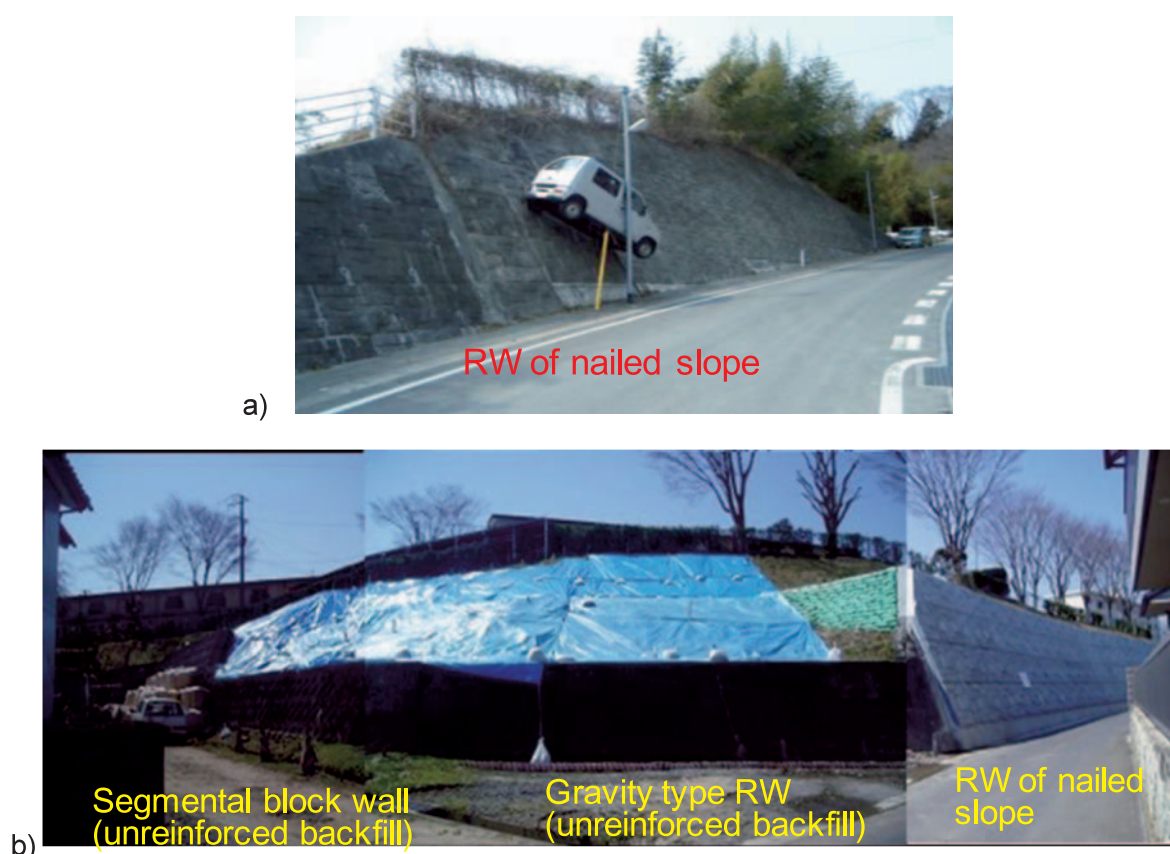
- a) In this earthquake, there were virtually no examples of damage to nailed cut natural slopes. For example, in Onagawa town, Miyagi Prefecture, there was no damage to a nailed cut natural slope that was inundated by the tsunami after being subjected to an earthquake motion reaching seismic intensity 6 or higher (Fig. 3-3a). In another example, an existing embankment in Sukagawa City, Fukushima Prefecture suffered from a slip failure in the backfill of a gravity-type retaining wall and a modular block retaining wall, but there was no damage to the adjacent retaining wall with nailed backfill and natural slope (Fig. 3-3b).

Fig. 3-3 a) Nailed wall of cut slope that survived the earthquake; and b) damaged conventional retaining walls (segmental block wall and gravity type wall) and an adjacent undamaged nailed wall of cut slope (Kodaka, T.)

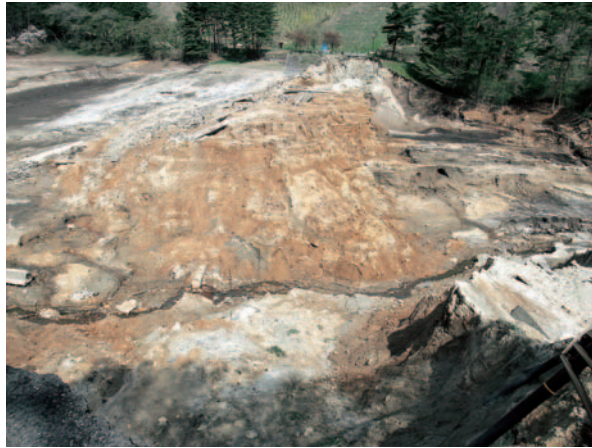
Fig. 3-4 Failure of Fujinuma dam in Sukagawa City, Fukushima Prefecture (Yasuda, S.)

A major future issue to be dealt with at the national level is to identify those fill-type dams among the older ones that were not designed and constructed according to recent standards that could cause damage downstream, and then to carry out appropriate strengthening.

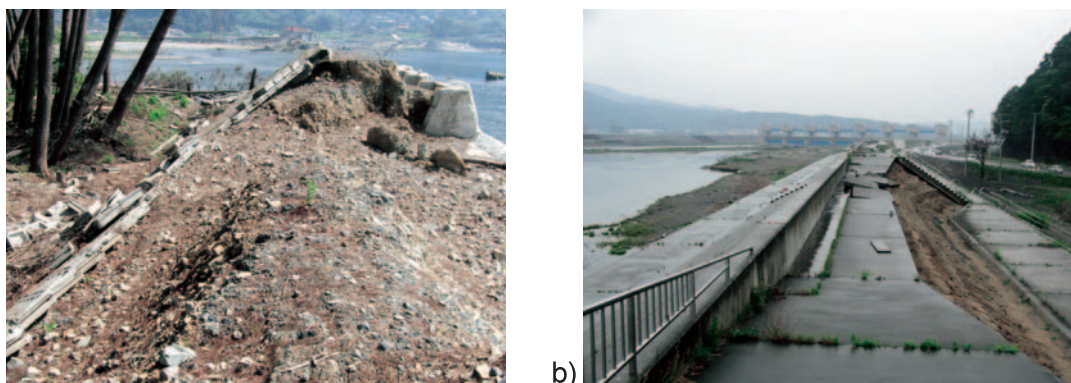
Most tsunami defenses ((breakwaters, tidal barriers, coastal dikes, river dikes in the vicinity of river mouths, etc.) functioned as expected until the tsunami exceeded the anticipated height. Thereafter, most collapsed due to foundation failure caused by scouring and erosion associated with the overflowing water. Coastal dikes of the embankment type are faced with concrete on three sides: the two sloping surfaces and the crest. However, in many cases, the overflowing tsunami caused strong upward suction as water rushed down the landward face, leading to peeling of the crest slab and the upper part of the concrete slab on the landward side, both not tied to the embankment. As soon as this happened, scouring of the embankment began, leading eventually to complete loss of the cross-section. Figure 3-5 shows an example of the early stage of this pattern of collapse.

Fig. 3-5 Embankment-type coastal dikes; the concrete slab at the crest and the top concrete panel on the downstream slope were lifted up and washed away followed by the start of erosion of the backfill caused by over-flow of tsunami; a) Koshikiri, Sanriku-cho, Ohunato City; and b) Tsugaruishi, Miyako-minami (note: the full-section of dike was lost at sections close to these sites) (Tatsuoka, F.)

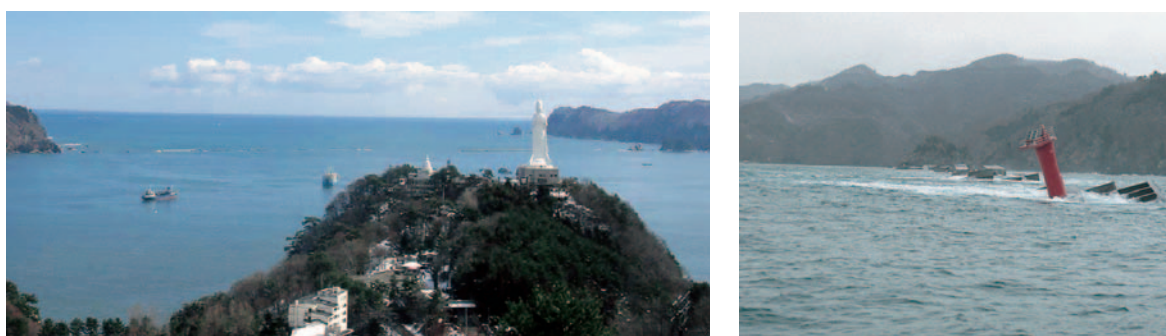
Still, there were breakwaters and tidal barriers that contributed to reducing the force of the tsunami, such as the breakwater at Kamaishi (Fig. 3-6). In general, however, the mechanisms by which collapse proceeds and then leads to complete loss of function (but in some cases, functions have been partially maintained) remain unclear, so future countermeasures will have to be developed on the basis of investigations of damage and follow-up research (discussed later). Not only will these problems with tsunami defenses need to be solved, but also issues with multiple tsunami defense facilities and evacuation systems (discussed later).

Fig. 3-6 Damage to a breakwater by tsunami at Kamaishi Port (by the courtesy of PARI)

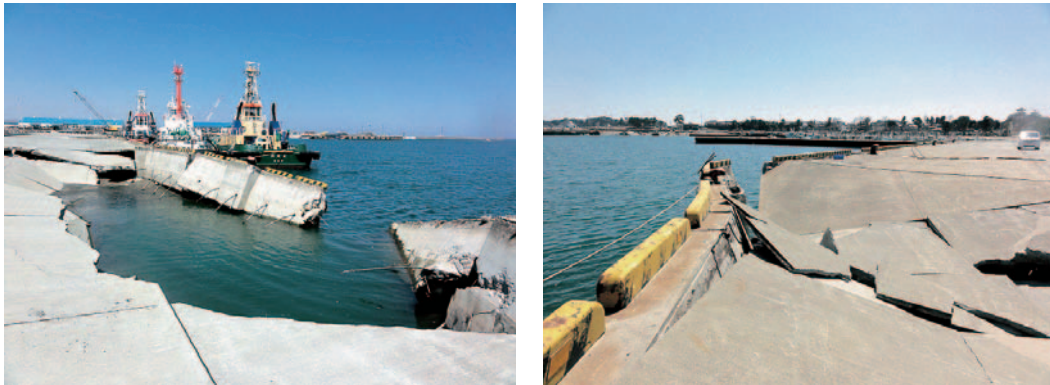
Fig. 3-7 Damage to a sheet pile type quay wall at Soma Port (by the courtesy of PARI)

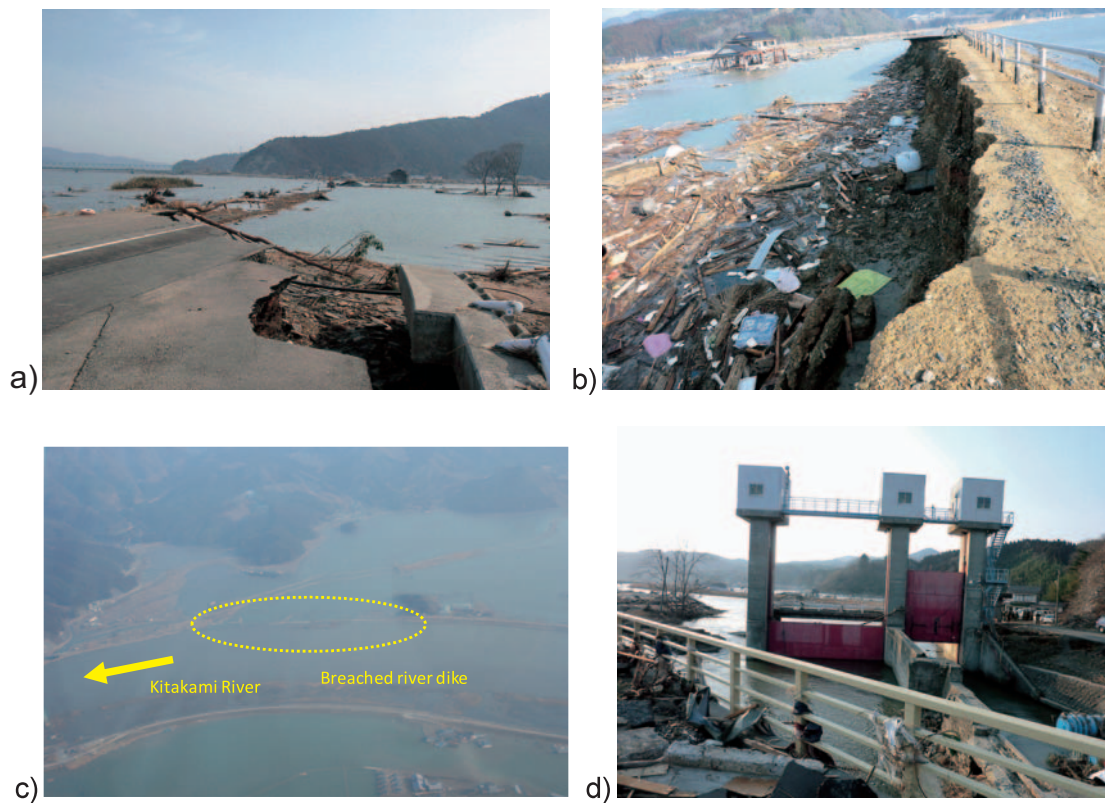
Fig. 3-8 Damage by tsunami around the river mouth of Kitakami River: a) breach of the river dike on the right bank 4 km from the river mouth; b) breach of the river dike on the left bank 3.0 km from the river mouth; c) an air view of the breached right bank; and d) Damage to Second Tsukihama water gate on the left bank at the river mouth (by the courtesy of the Ministry of Land, Infrastructure, Transport and Tourism)

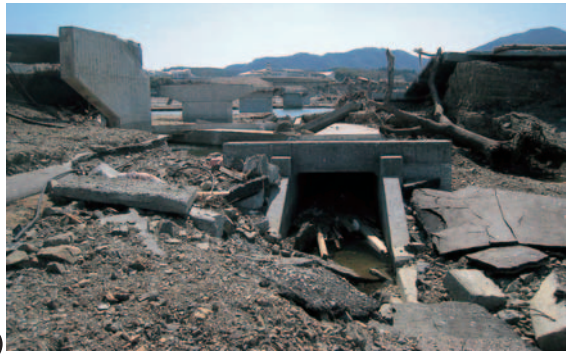
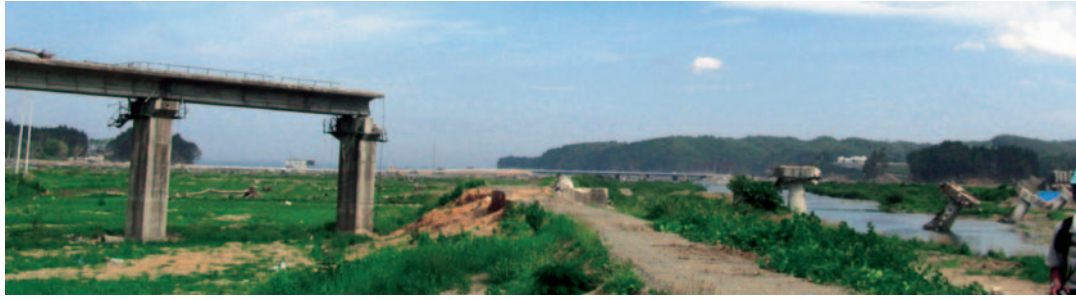
Fig. 3-9 a) Collapse of river dike in the upper reach of a bridge abutment on the left bank of Tsuya Rive, Motoyoshi, Kesen-numa City, Miyagi Prefecture (Uzuoka, R.) : b) a view from the upstream of Tsuyagawa Bridge, between Motoyoshi and Rikuzenkoizumi stations, Kesen-numa line, East Japan Railway: several girders were washed away and piers in the river tilted by tsunami (Tatsuoka, F.)

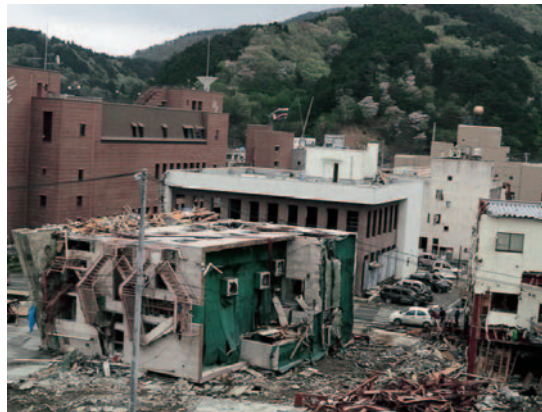
- Expressways (closure of roads and interchanges due to tsunami deposits)
- Overturning of low- and medium-rise buildings associated with pull-out of pile foundations (Fig. 3-10)

Fig. 3-10 A RC building over-turned by tsunami, Onagawa (Kodaka, T.)

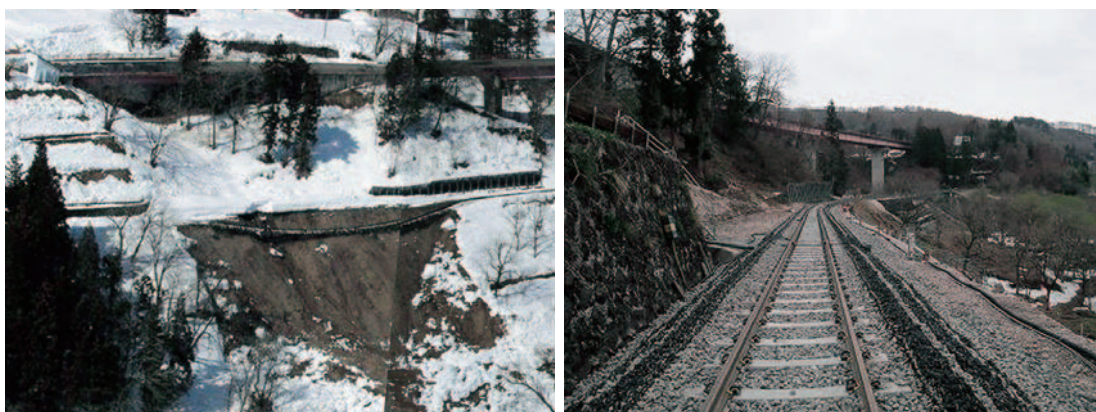
Fig. 3-12 a) Embankment collapsed in the Nagano-Niigata Border Earthquake induced the next day after the 2011 Great earthquake; and b) reconstruction to embankment retained by a GRS-RW having a FHR facing, between Yokokura and Morinomiya, JR East Iiyama Line (by the courtesy of the East Japan Railway Co.)

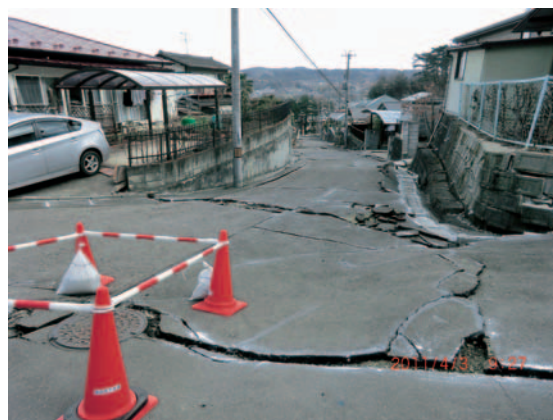
Fig. 3-14 A view of typical damaged houses in hillside residential areas, Oritate, Aoba District, Sendai City (Kazama, M.)

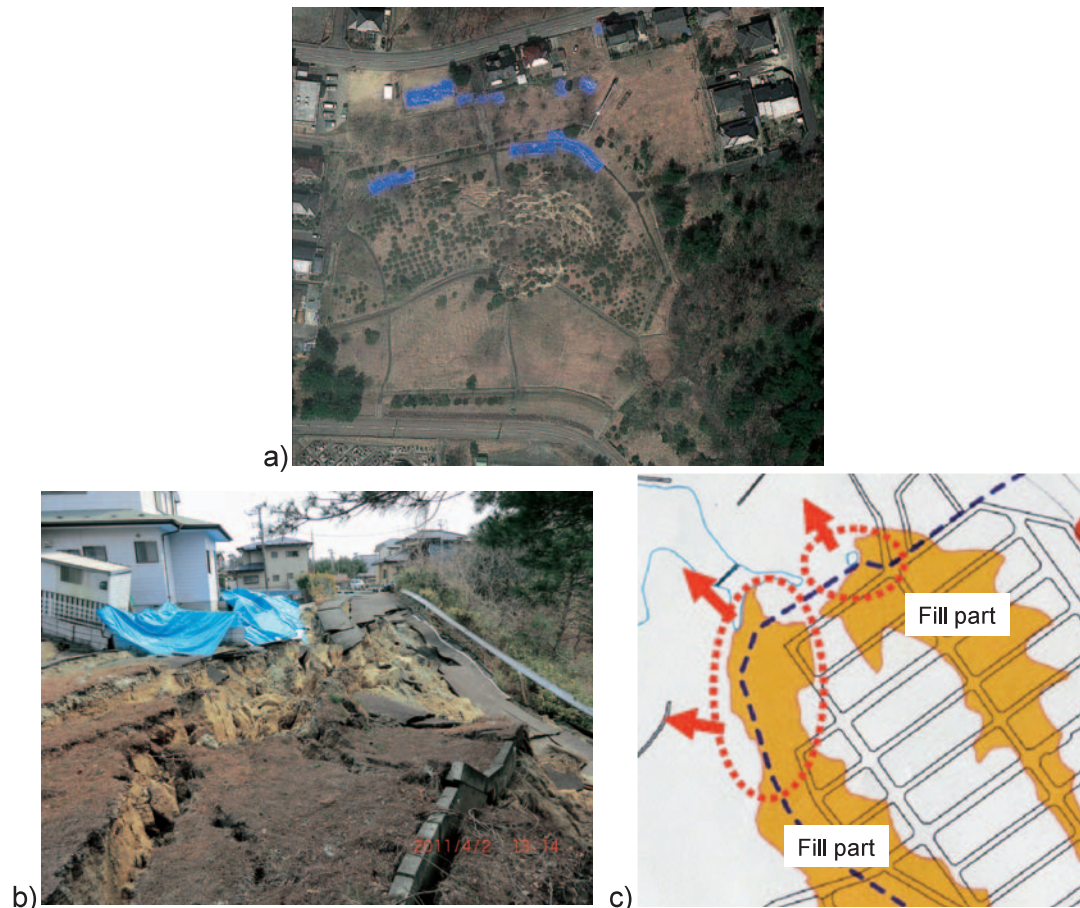
Figure 3-16a shows an example from Shiroishi City in Miyagi Prefecture, where the earthquake damage was of pattern b). Here, land developed residential land that suffered from damage in the 1978 Miyagi Prefecture Oki Earthquake was damaged again. However, as a result of countermeasures that included the construction of water collection wells, damage was limited this time. At Midorigaoka, Taihaku-ku, Sendai City, countermeasures had been carried out through a combination of restraining piles and methods to lower the groundwater level; as a result, slip failure of the whole embankment was avoided in this earthquake. There are examples from the 2004 Niigata Chuetsu Earthquake and the 2007 Niigata Chuetsu Oki Earthquake of residential land that was damaged once, and then again suffered damage.

Fig. 3-16 a) Typical re-damage case of residential fill ground that had been damaged by the 1978 Miyagiken-oki Earthquake, Shiroishi City, Miyagi Prefecture; b) another typical damage case of embankment in narrow valleys; and c) the location of damage case shown in Fig. b in the plan view at the site (Sato, S.)

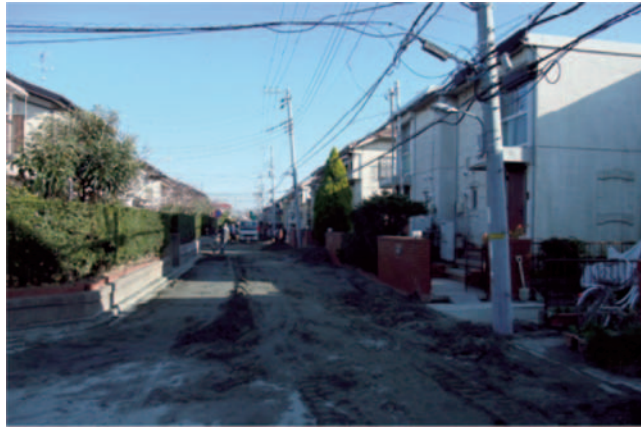
Fig. 3-18 Damaged houses and road due to soil liquefaction (Yasuda, S.)

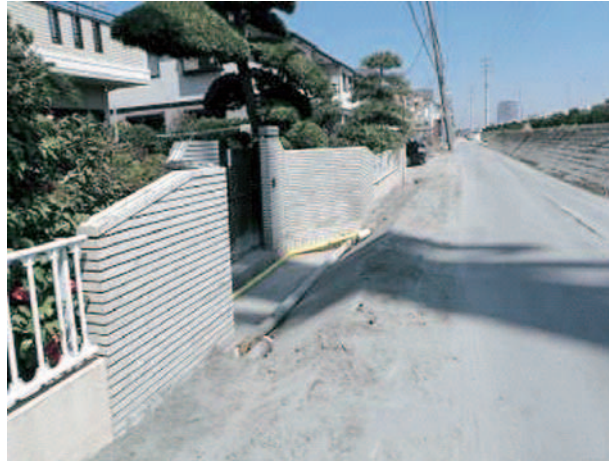
Fig. 3-21 Differential settlements of private house and road, Urayasu City (Ishihara, M.)

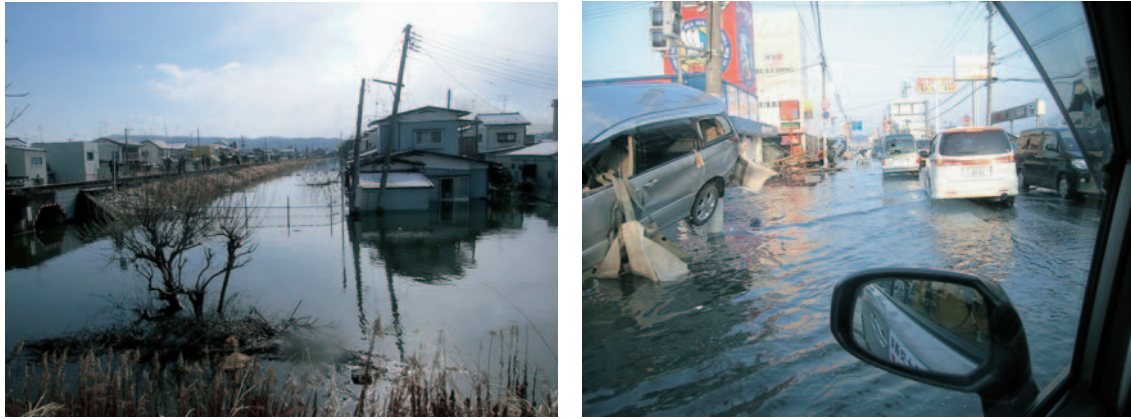
Fig. 3-24 Inundation by ground subsidence, two days after the earthquake, Ishinomaki City, Miyagi Prefecture (by the courtesy of Tohoku Regional Bureau of MLIT)

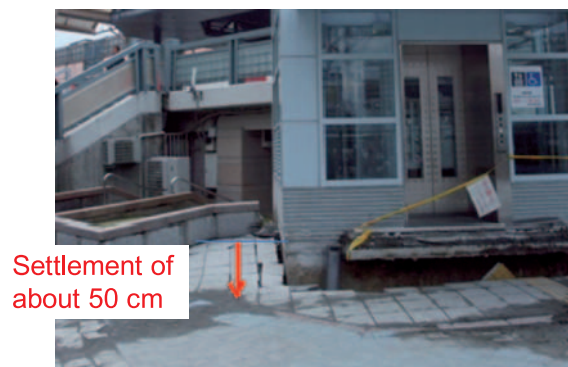
Fig. 3-27 A typical case of ground settlement by soil liquefaction, Urayasu City (Yasuda, S.)

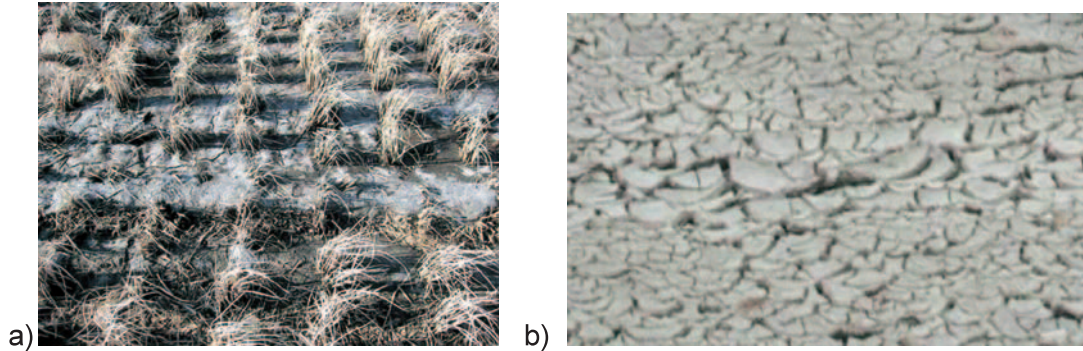
Fig. 3-28 Damage to agricultural areas by tsunami at Watari Yamamoto District, Miyagi Prefecture: a) rice field covered by salt from sea water that came via a drainage (the ground subsided); and b) rice field covered by tsunami deposits with a thickness of several centimeters (Mohri, H.)

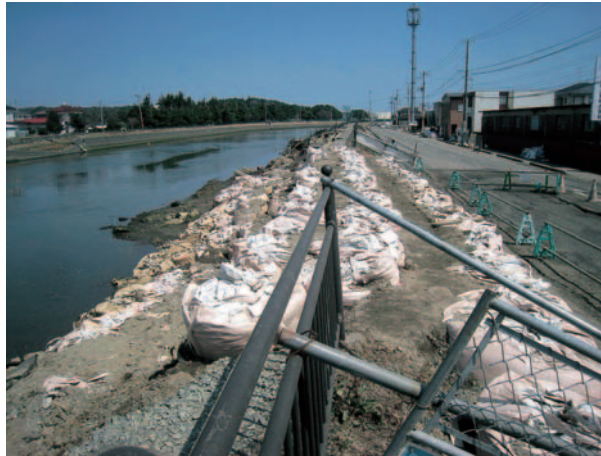
Fig. 3-30 Damage to river dike on the right bank of Sunaoshi River caused by earthquake motion, Tagajyo City, Miyagi Prefecture, and resulting inundation of lowland by tsunami (by Uzuoka, R.)

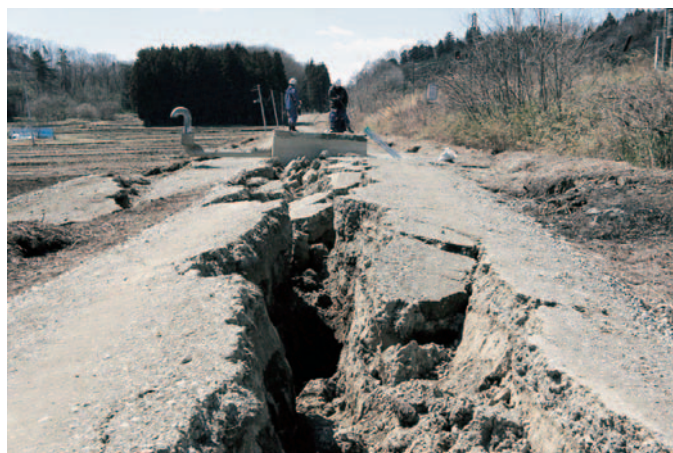
Fig. 3-31 Damage to a main agricultural pipeline for a length of about 1.4 km due to uplift caused by liquefaction of backfill soil. The largest depth of opening was about 1.6 m (Mohri, H.)

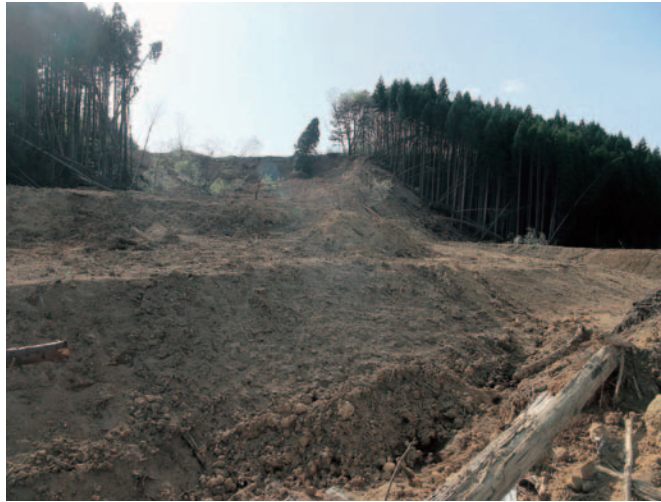
Fig. 3-32 Failure of a natural slope, Hanokidaira, Shirakawa City (Yasuda, S.)

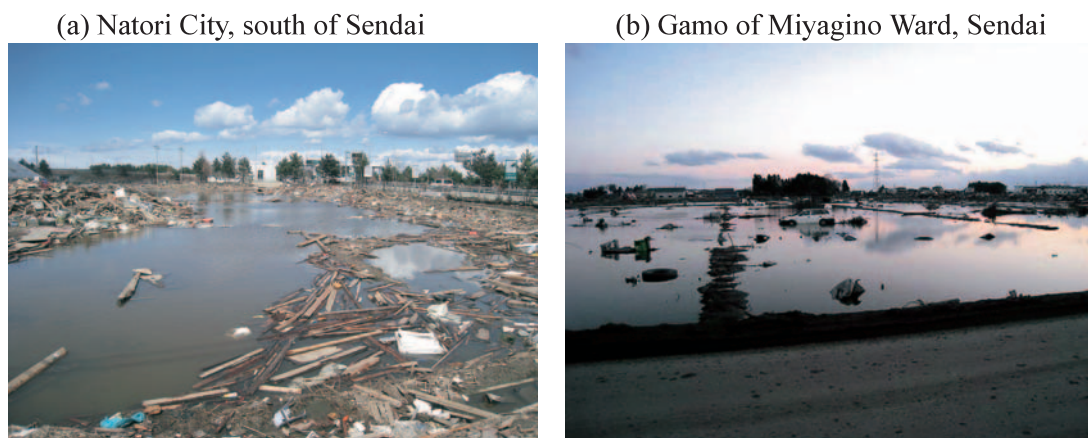
Fig. 2 Coseismic subsidence in Sendai (Photographs by Daiken Suzuki, former student of University of Tokyo)

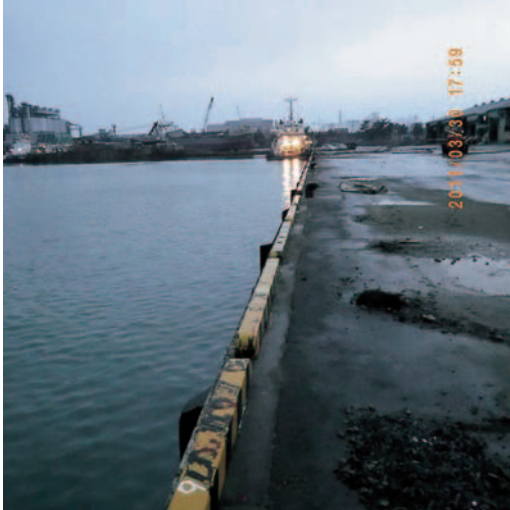
(a) Intact quay wall

Fig. 10 Post-tsunami situation in Ishinomaki Harbor to the east of Sendai

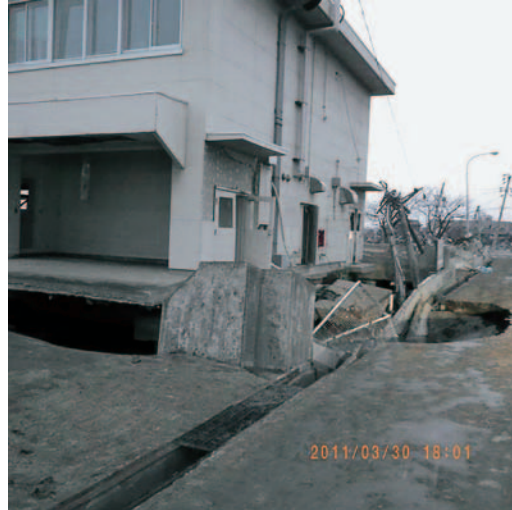
(b) Erosion in building foundation

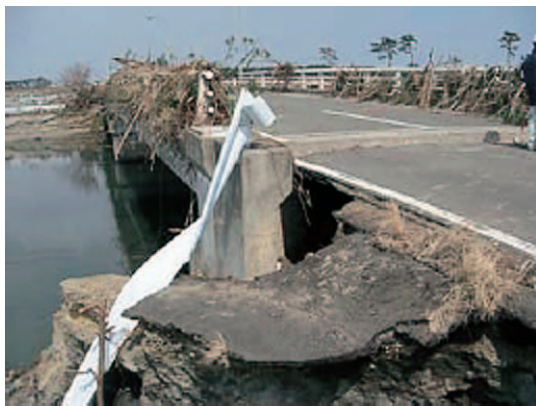
Fig. 11 Erosion of embankment at bridge abutment after tsunami Strike (Iwanuma in Miyagi Prefecture)

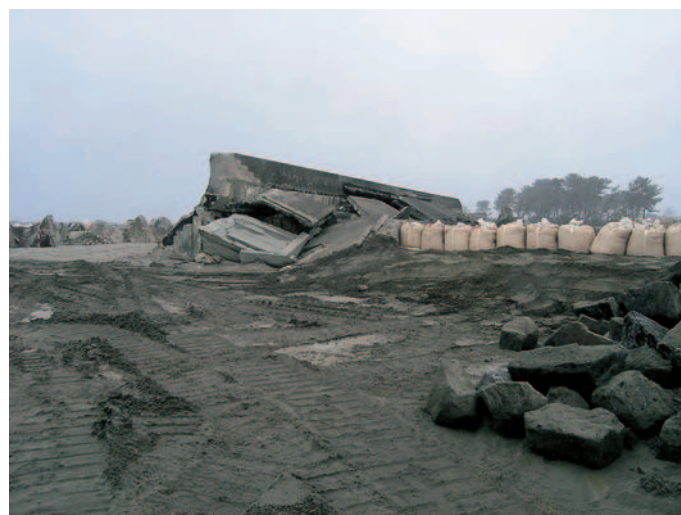
Fig. 13 Destroyed sea wall near Abukuma River mouth
