Geotechnical damage caused by the recent gigantic earthquake in Japan

Ikuo Towhata University of Tokyo

Presentation at 3rd INTERNATIONAL CONFERENCE ON GEOTECHNICAL ENGINEERING FOR DISASTER MITIGATION AND REHABILITATION (GEDMAR) in Semarang, Indonesia

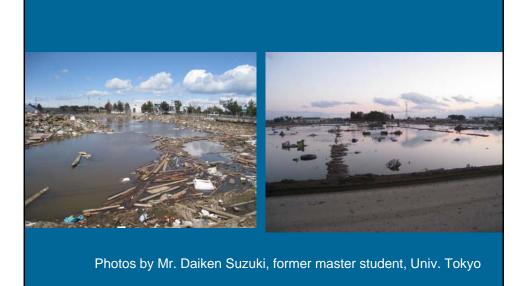
Coseismic subsidence in coastal area

Ground level is lower than before; Difficulty in drainage Risk of flooding in typhoon season

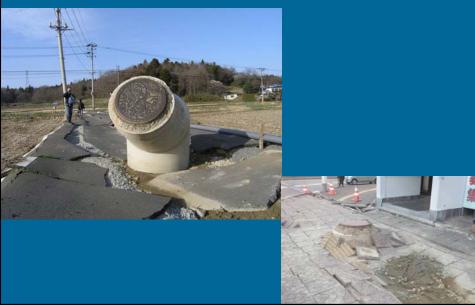
Floating of sewage manhole caused by liquefaction of ground and backfill

Sewage pipelines were destroyed at extremely many places

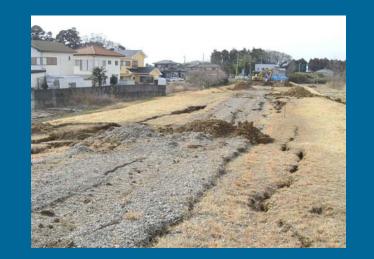
Liquefaction in former swamp; not indicated in liquefaction hazard map: public dispute

Ignorance of old topography and too much reliance on bore hole database

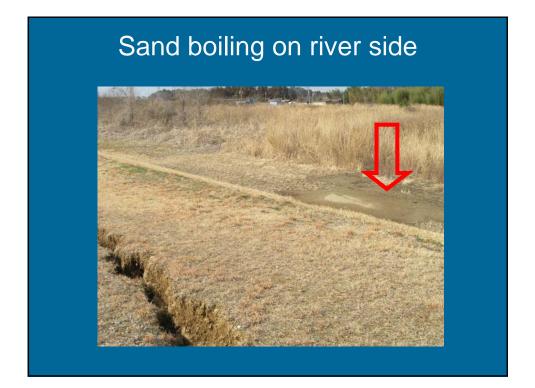
Liquefaction in foundation, subsidence, and lateral spread

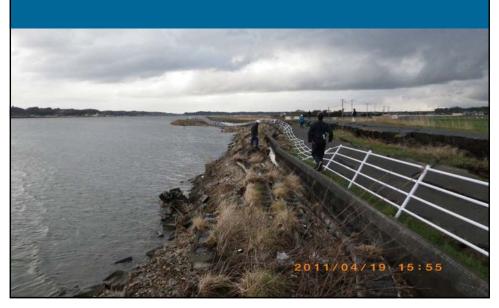
Liquefaction in foundation

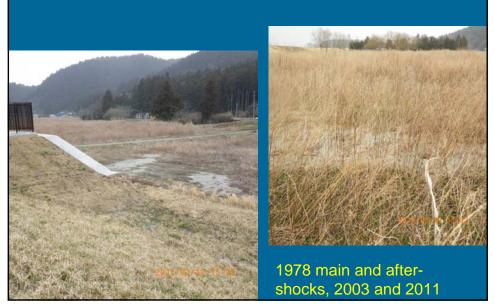
Repeated liquefaction; 4th time

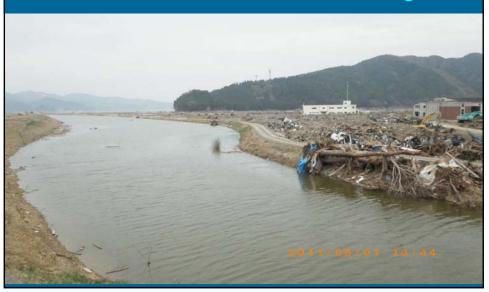
Situation was made worse by tectonic subsidence: insufficient levee height

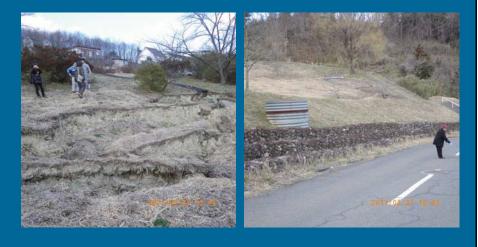
Damage in residential development in hilly area: cut and fill construction

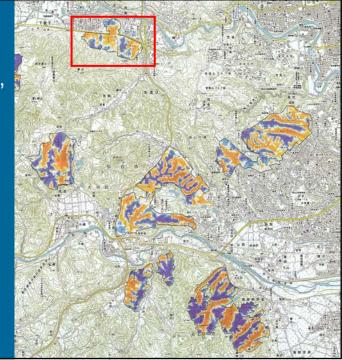
Site of previous slope failure in 1978

In Sendai City, there are many residential developments in hill areas:

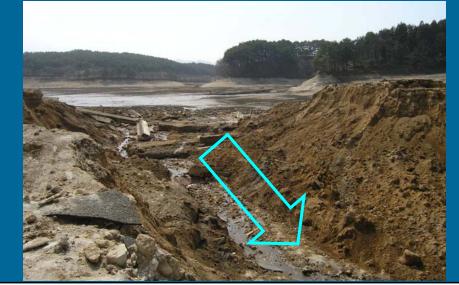
First dam was eroded and 150万m³ of water attacked a downstream village
