# **GEO-HAZARDS DURING EARTHQUAKES AND MITIGATION MEASURES**

**-LESSONS AND RECOMMENDATIONS FROM THE 2011 GREAT EAST JAPAN EARTHQUAKE-**

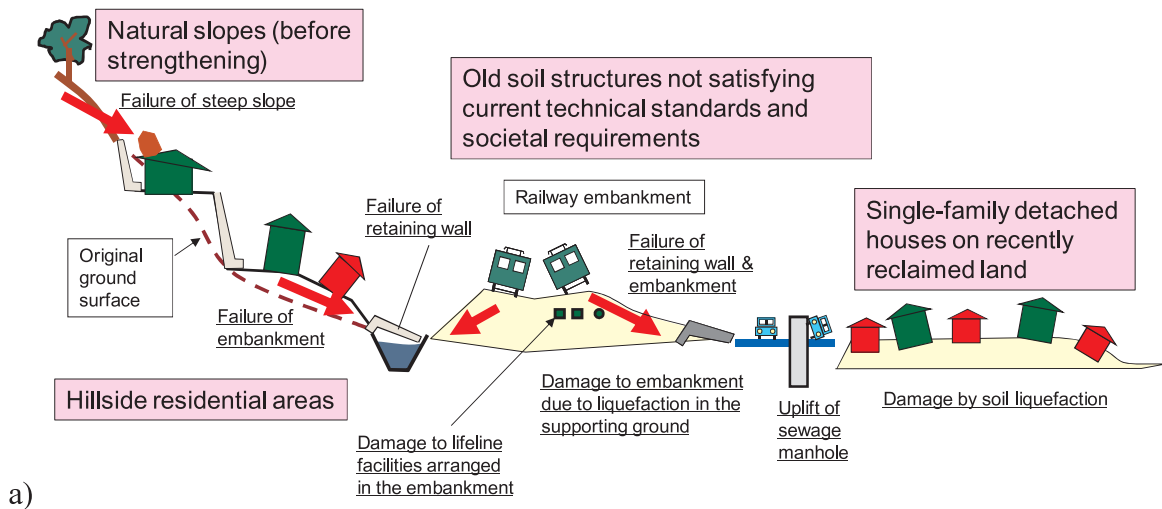
Note 1) Old soil structures that may not satisfy current technical standards and societal requirements. These are existing soil structures such as roads, railways, housing areas, reservoir dams, embankments, retaining walls, etc., river and coastal dikes, reclaimed land, and underground structures such as sewage manholes, piping, agricultural pipelines, etc., that have essentially been constructed in accordance with old technology and old standards, and that do not meet the functionality required by current technical standards and societal requirements. In the actual process, soil structures that are suspected of not satisfying the performance requirements of the current technical standards are subject to investigation of seismic stability, and the results determine whether the requirements are met or not.

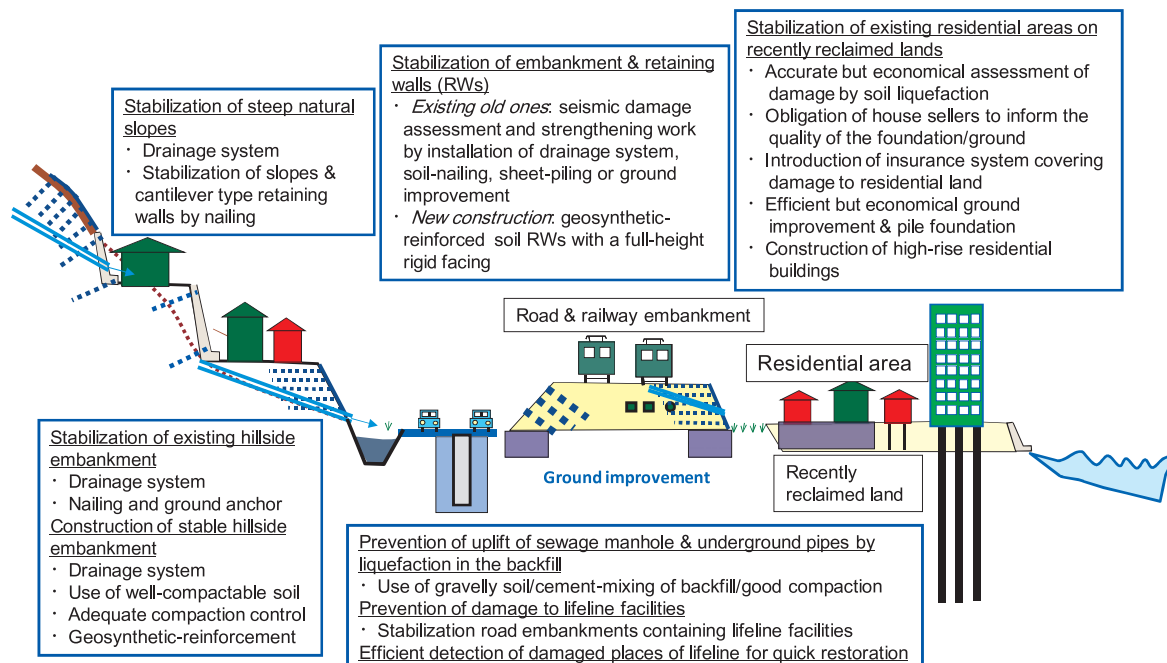
Fig. 2-1 Various geotechnical technologies to prevent and reduce geo-disasters in inland/coastal areas

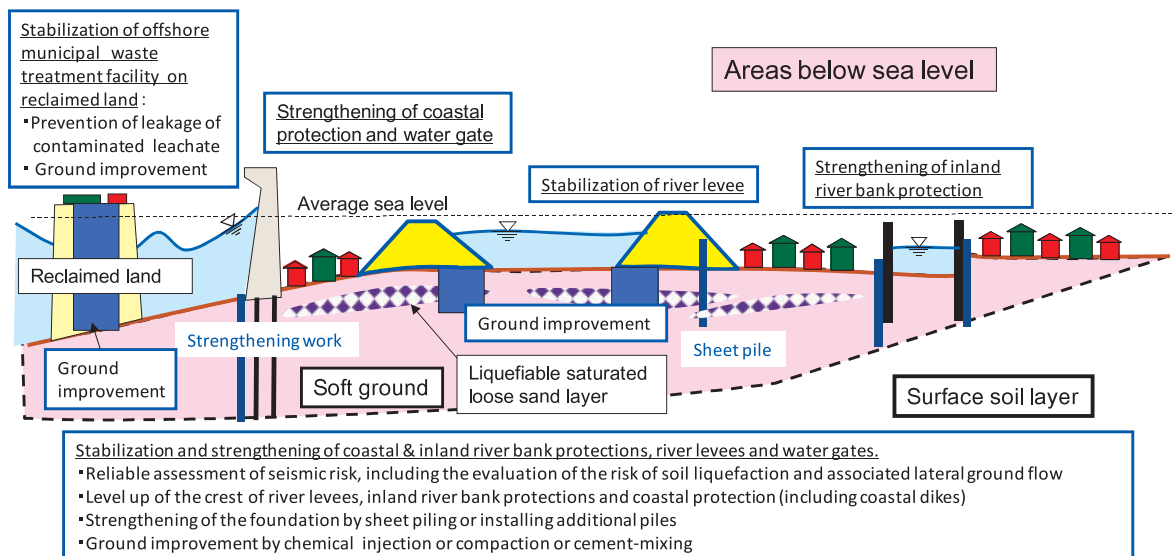
Fig. 2-3 Various geotechnical technologies to prevent and reduce geo-disasters in lowland areas

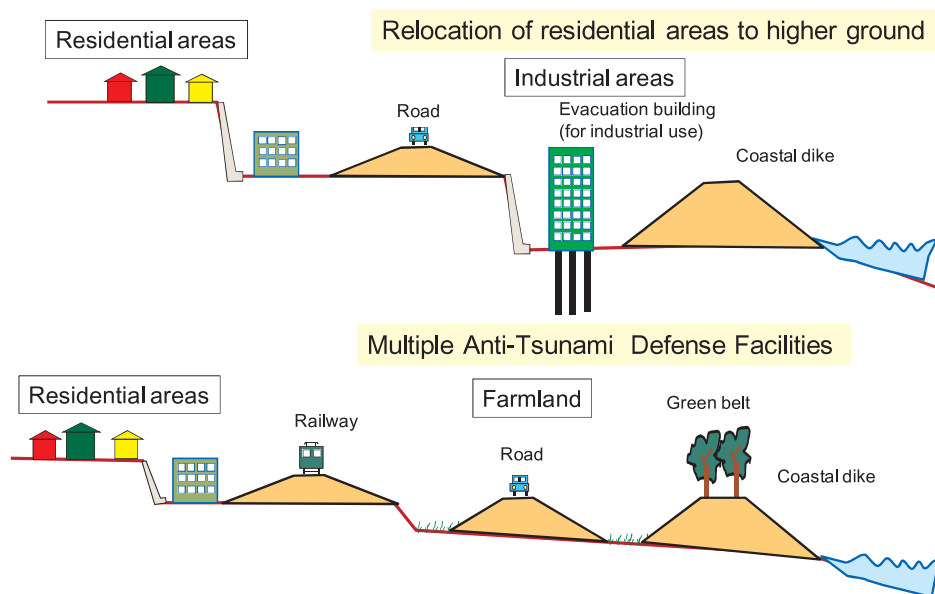
Fig. 2.4 Schematic diagrams showing applications of conventional geotechnical technologies to the restoration program (the first version) of Miyagi Prefecture (Asahi Newspaper, morning paper, 4<sup>th</sup> June, 2011)

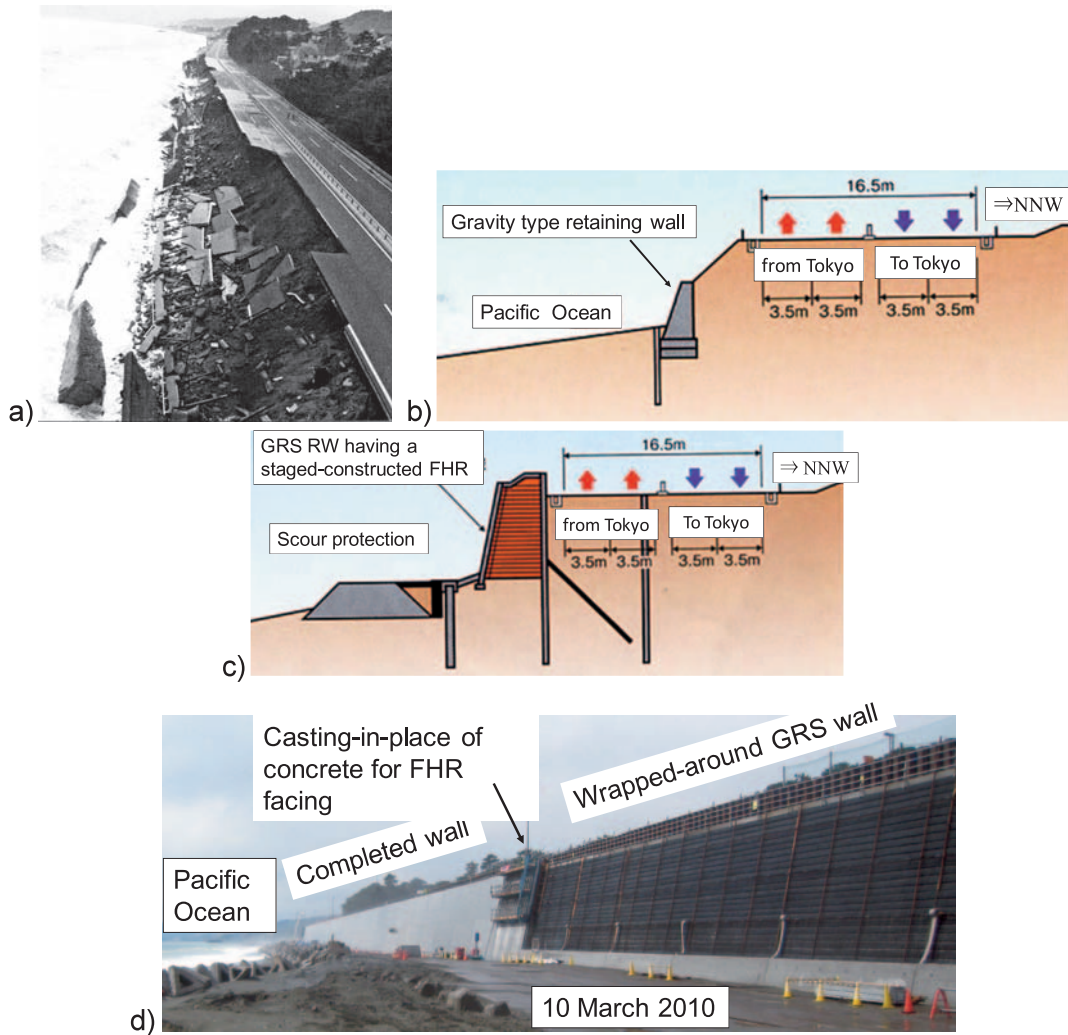
Fig. 2-7 Seawall of Seisho by-pass for National Road No. 1 in Kanagawa Prefecture, southwest of Tokyo: a) collapse for a length of about 1 km by Typhoon No. 9, 29<sup>th</sup> Aug. 2007; b) original structure; c) reconstructed seawall; and d) the wall during construction (a), b) & c): by the courtesy of the Ministry of Land, Infrastructure, Transport and Tourism; and d) by Tatsuoka, F.)

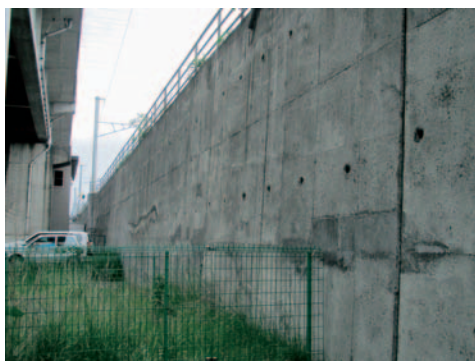
Fig. 2-8 Geosynthetic-reinforced soil retaining wall have a staged constructed full-height rigid facing for Tohoku line (railway), next to Natori River bridge, Sendai City; any damage by this earthquake (photo. by Okamoto, M.)

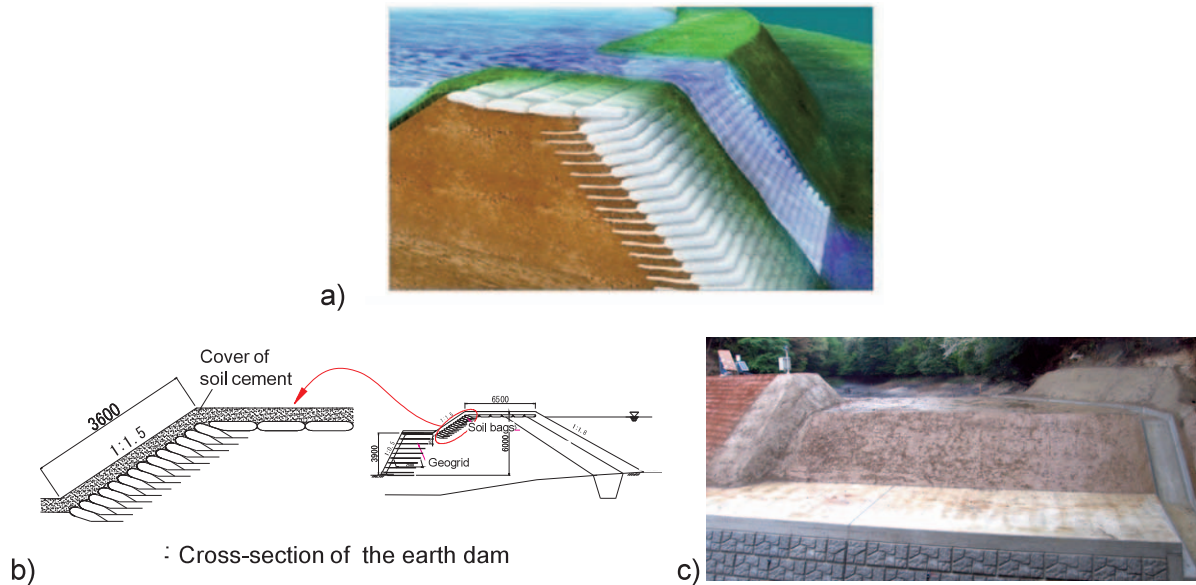
Fig. 2-9 a) artist's view of geosynthetic-reinforced earth dam; and b) &c) restoration of the spillway section of the earth-fill dam of Hirata Ike, Ishikawa Prefecture, that collapsed by the 2007 Noto-Hanto Earthquake (Mohri et al., 2009)

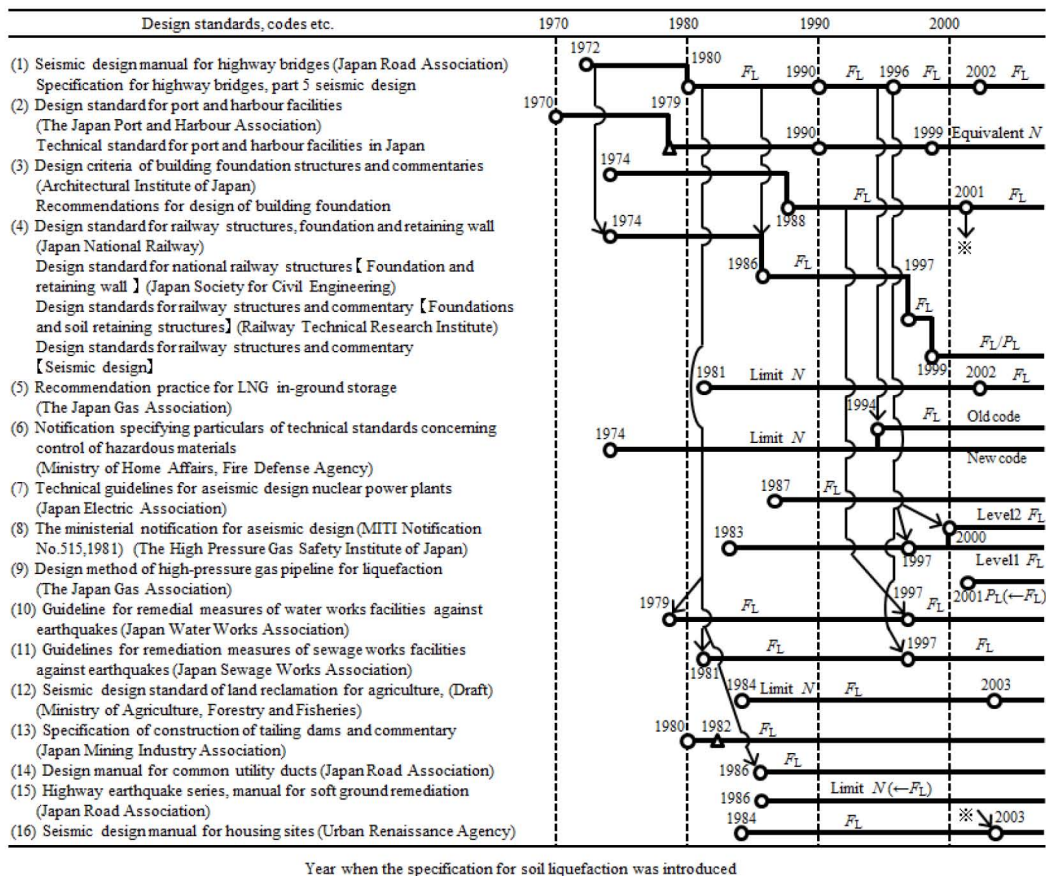
Fig. 3.1 History of inclusion of the terms for prediction and mitigation of soil liquefaction in Japanese design standards and codes for infrastructures

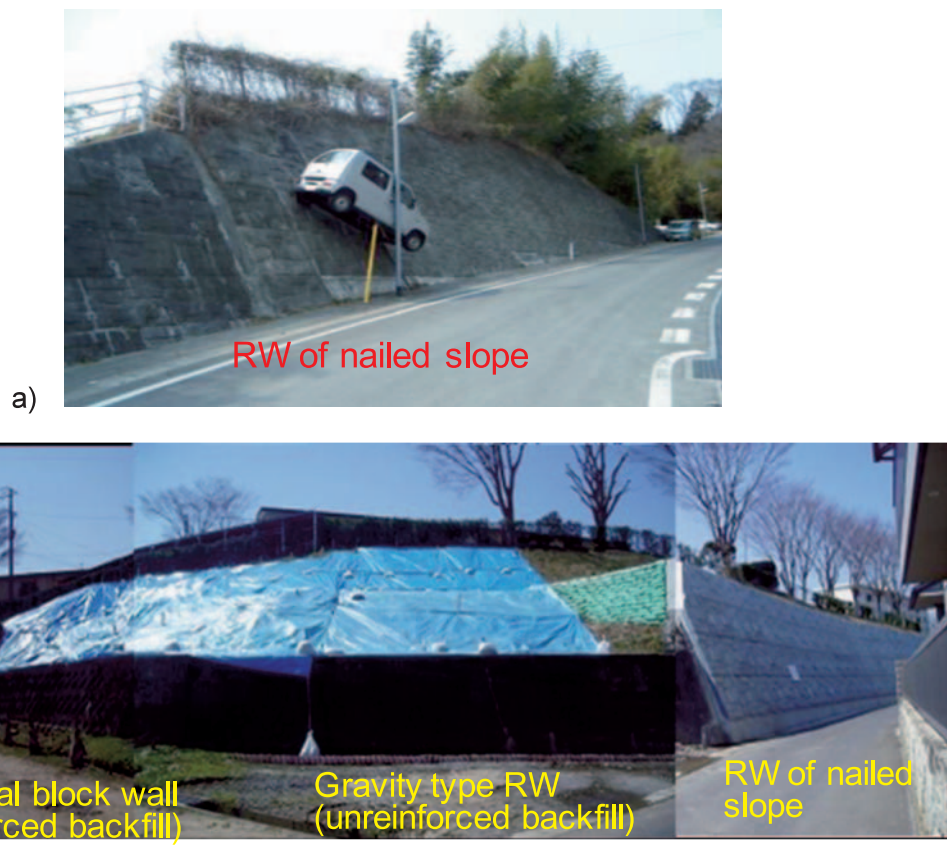
Fig. 3-3 a) Nailed wall of cut slope that survived the earthquake; and b) damaged conventional retaining walls (segmental block wall and gravity type wall) and an adjacent undamaged nailed wall of cut slope (Kodaka, T.)

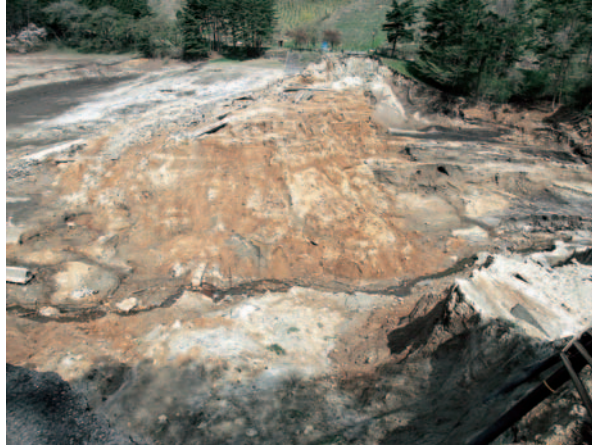
Fig. 3-4 Failure of Fujinuma dam in Sukagawa City, Fukushima Prefecture (Yasuda, S.)

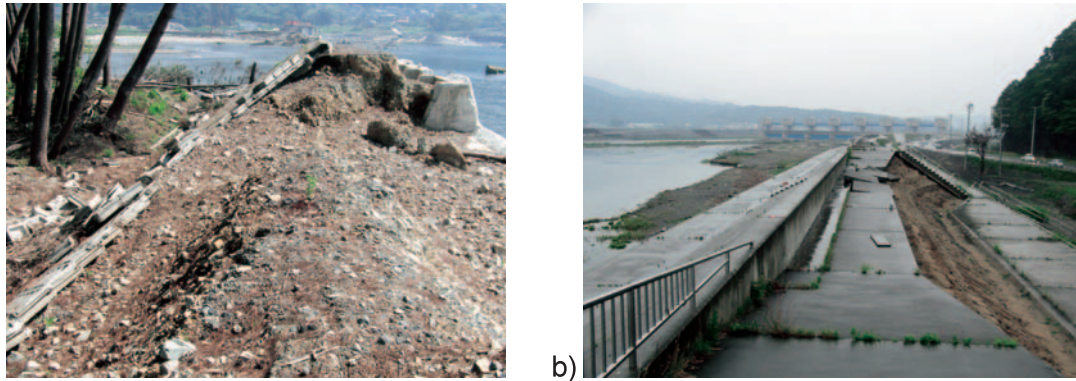
Fig. 3-5 Embankment-type coastal dikes; the concrete slab at the crest and the top concrete panel on the downstream slope were lifted up and washed away followed by the start of erosion of the backfill caused by over-flow of tsunami; a) Koshikiri, Sanriku-cho, Ohunato City; and b) Tsugaruishi, Miyako-minami (note: the full-section of dike was lost at sections close to these sites) (Tatsuoka, F.)

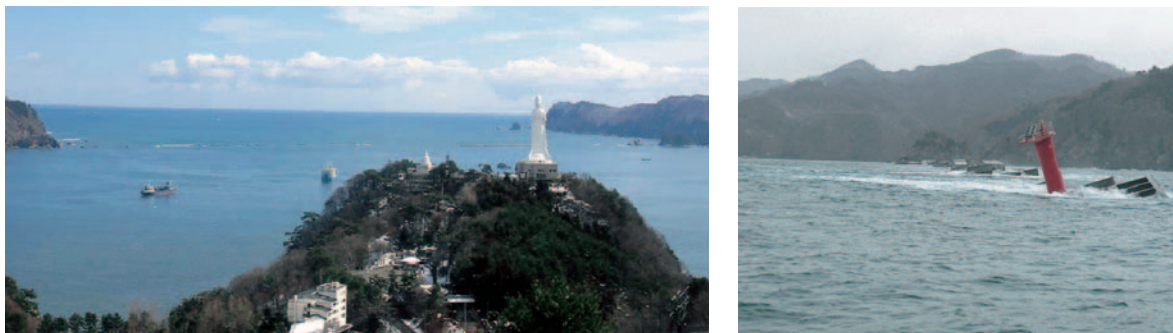
Fig. 3-6 Damage to a breakwater by tsunami at Kamaishi Port (by the courtesy of PARI)

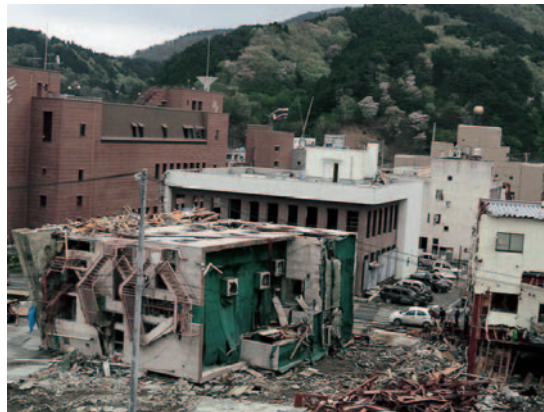
Fig. 3-10 A RC building over-turned by tsunami, Onagawa (Kodaka, T.)

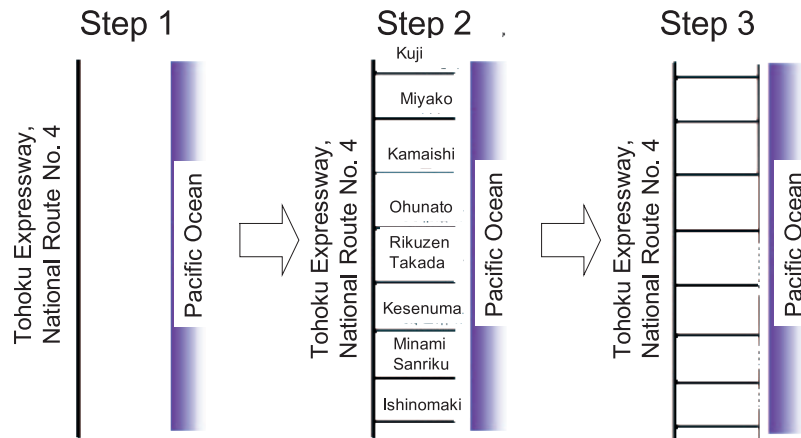
Fig. 3-11 Restoration of inland north-south routes by a strategy called the “teeth” of the comb (by the courtesy of the Ministry of Land, Infrastructure, Transport and Tourism).

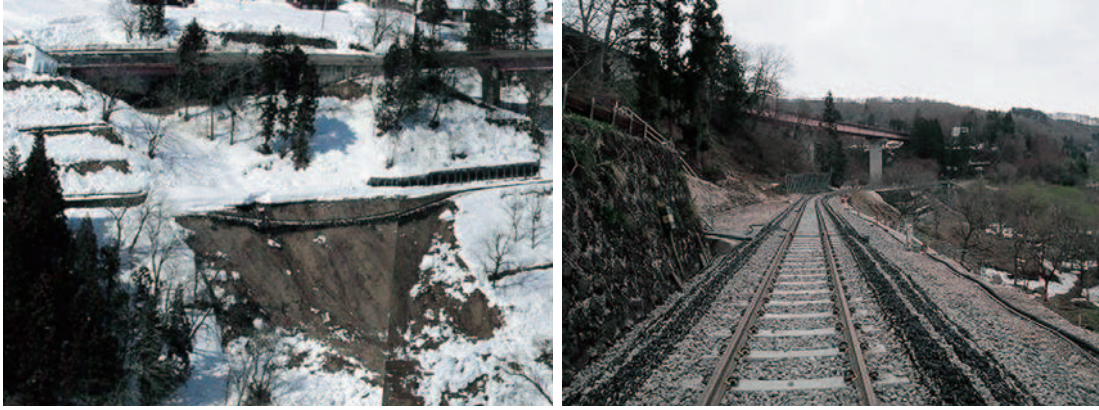
Fig. 3-12 a) Embankment collapsed in the Nagano-Niigata Border Earthquake induced the next day after the 2011 Great earthquake; and b) reconstruction to embankment retained by a GRS-RW having a FHR facing, between Yokokura and Morinomiya, JR East Iiyama Line (by the courtesy of the East Japan Railway Co.)

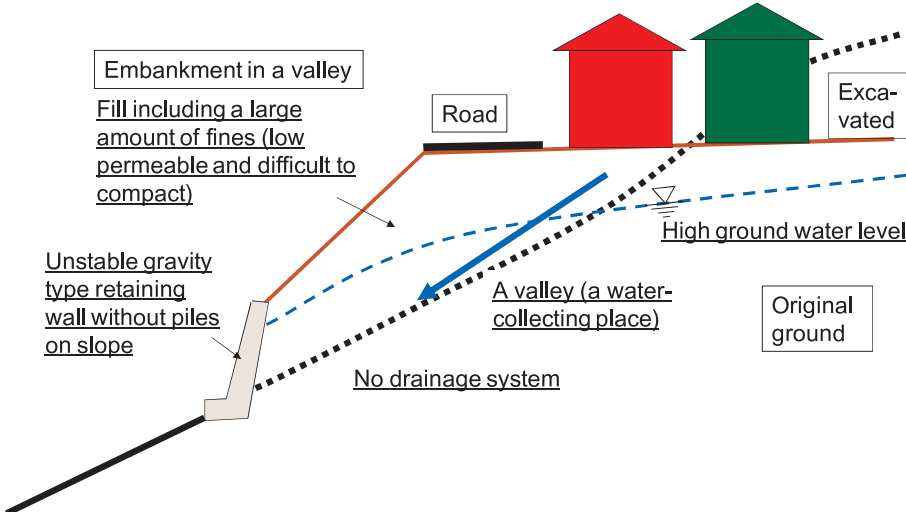
Fig. 3-13 Schematic figure showing several majors causes for the failure of embankment in a valley in a hillside residential area

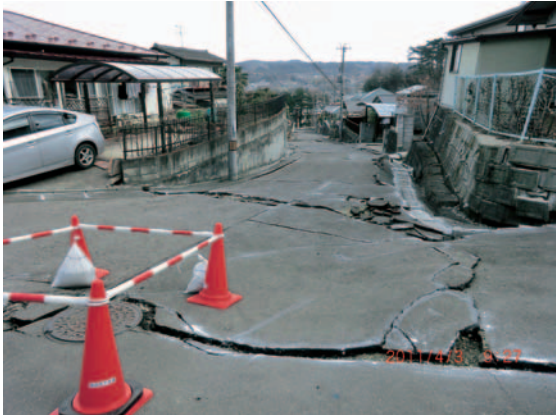
Fig. 3-14 A view of typical damaged houses in hillside residential areas, Oritate, Aoba District, Sendai City (Kazama, M.)

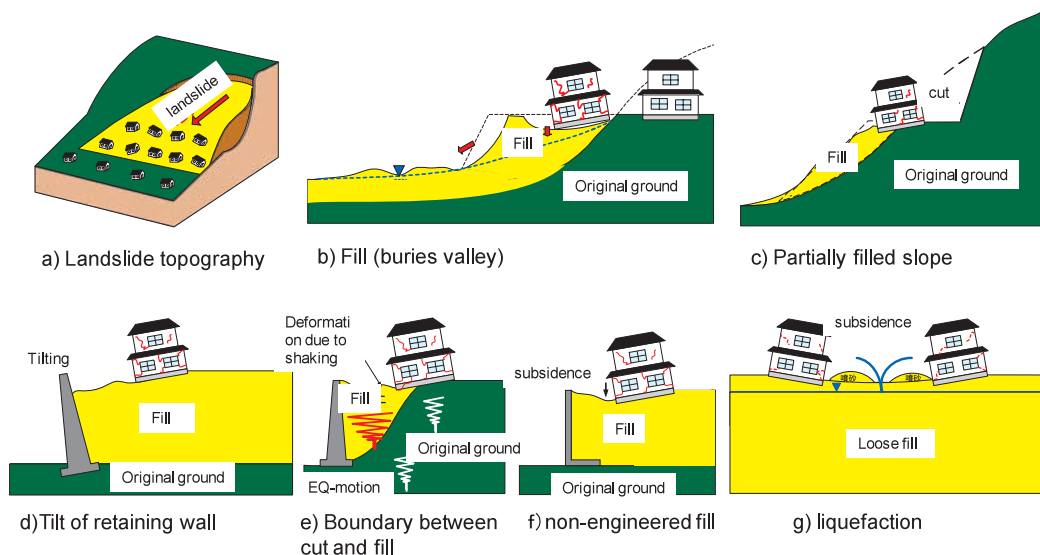
Fig. 3-15 Classification of damage mechanism of residential fill ground (Kazama, M.)

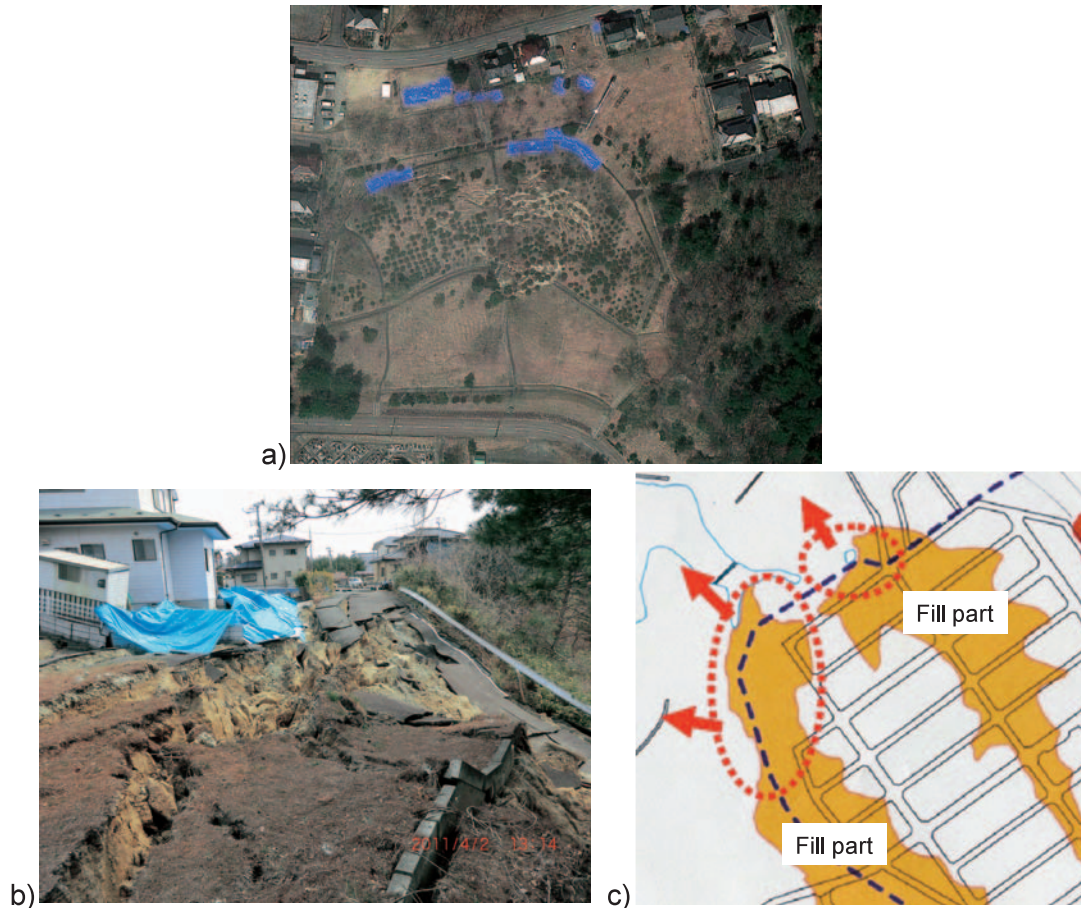
Fig. 3-16 a) Typical re-damage case of residential fill ground that had been damaged by the 1978 Miyagiken-oki Earthquake, Shiroishi City, Miyagi Prefecture; b) another typical damage case of embankment in narrow valleys; and c) the location of damage case shown in Fig. b in the plan view at the site (Sato, S.)

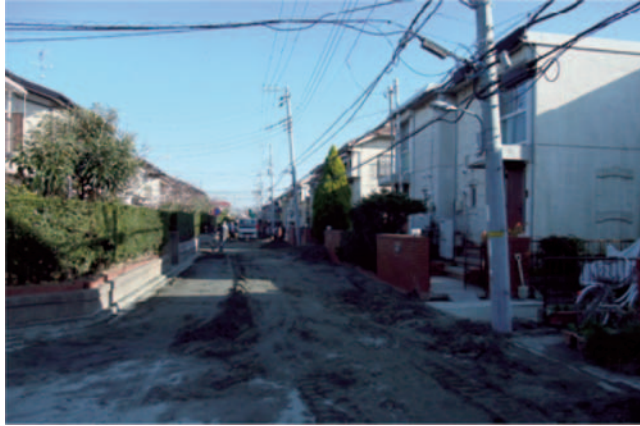
Fig. 3-18 Damaged houses and road due to soil liquefaction (Yasuda, S.)

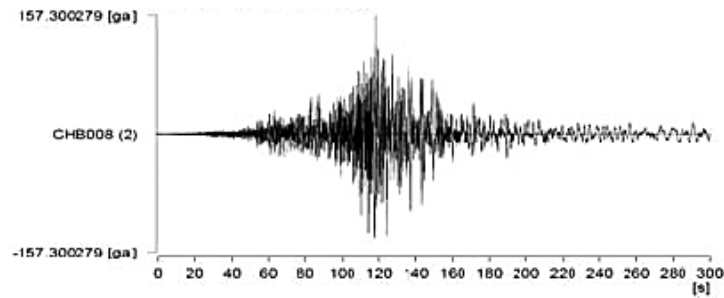
Fig. 3-19 Time history of horizontal ground acceleration at a K-NET station in Urayasu City (the PGA= 157,3 cm/s<sup>2</sup>)

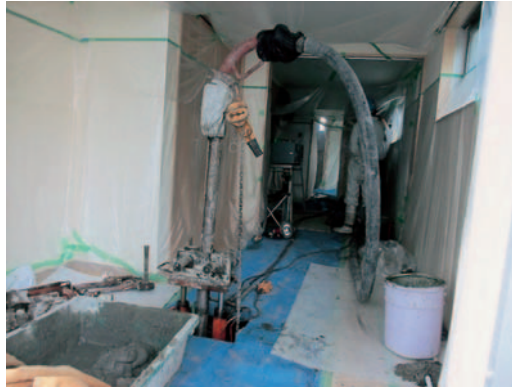
Fig. 3-20 Ground improvement by compaction grouting for restoration of a private house damaged by soil liquefaction, Urayasu City (Yasuda, S.)

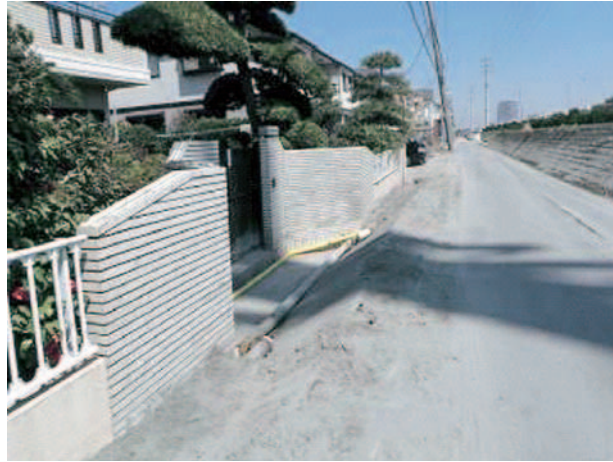
Fig. 3-21 Differential settlements of private house and road, Urayasu City (Ishihara, M.)

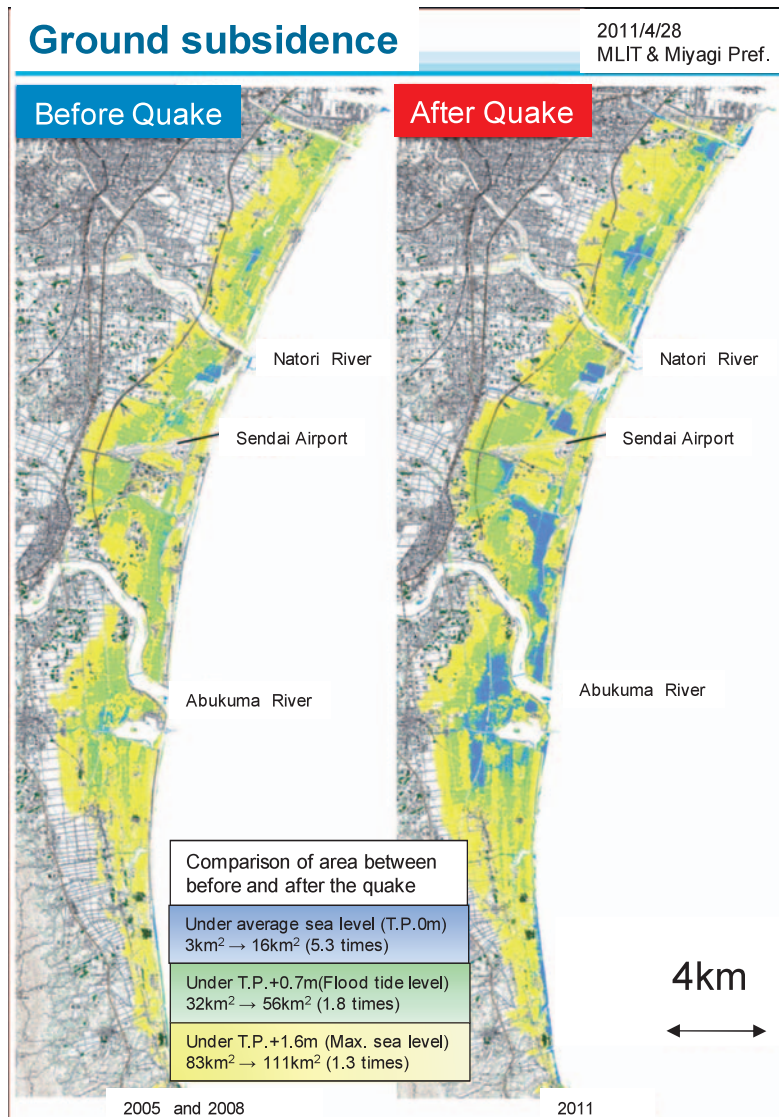
Fig. 3-22 Areas of ground subsidence, South region of Miyagi Prefecture (by the courtesy of Tohoku Regional Bureau of MLIT and Miyagi Prefecture Government)

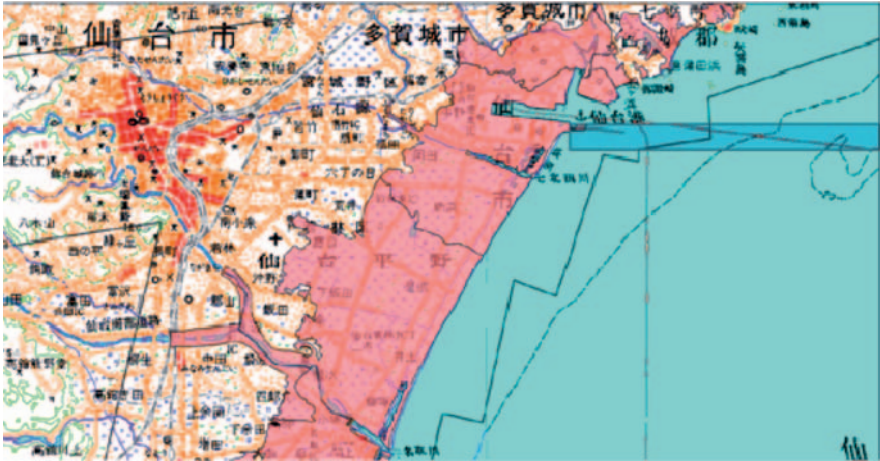
Fig. 3-23 Inundated areas, Sendai Plain (by the courtesy of GSI, Geospatial Information Agency of Japan)

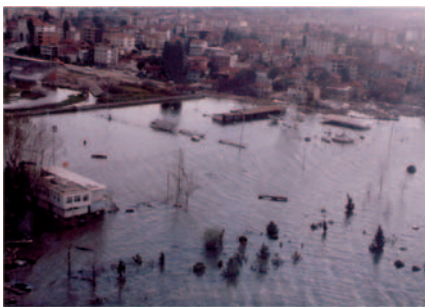
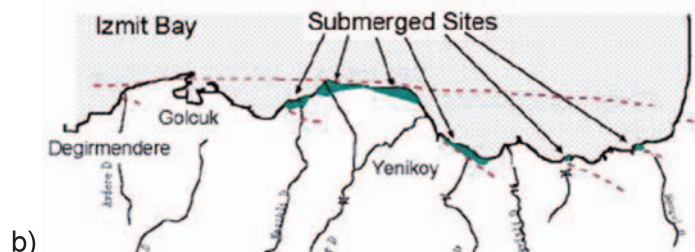
a) b)  
Fig. 3-25 Submerged area in Gölçük due to ground subsidence during the 1999 Kocaeli, Turkey earthquake (Yasuda, S.)

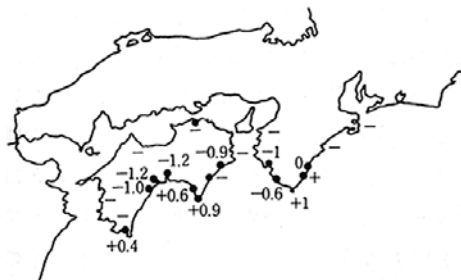
Fig. 3-26 Ground subsidence and heaving (in meter) by the Nankai Earthquake (21th December 1946) (after Kawasumi, Hiroshi)

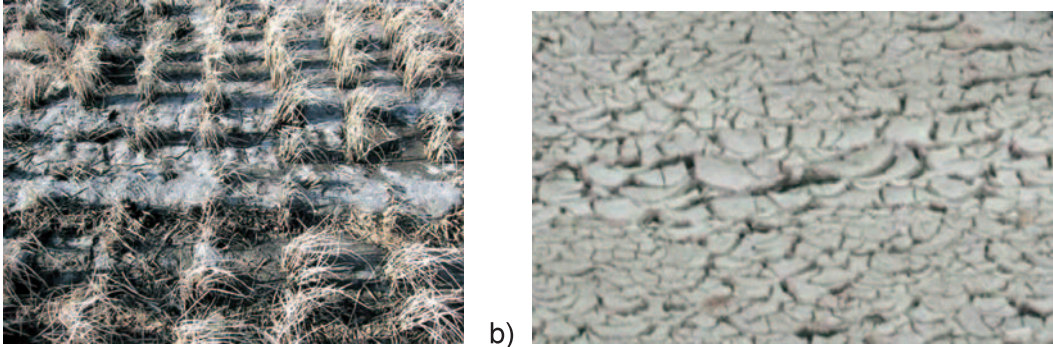
Fig. 3-28 Damage to agricultural areas by tsunami at Watari Yamamoto District, Miyagi Prefecture: a) rice field covered by salt from sea water that came via a drainage (the ground subsided); and b) rice field covered by tsunami deposits with a thickness of several centimeters (Mohri, H.)

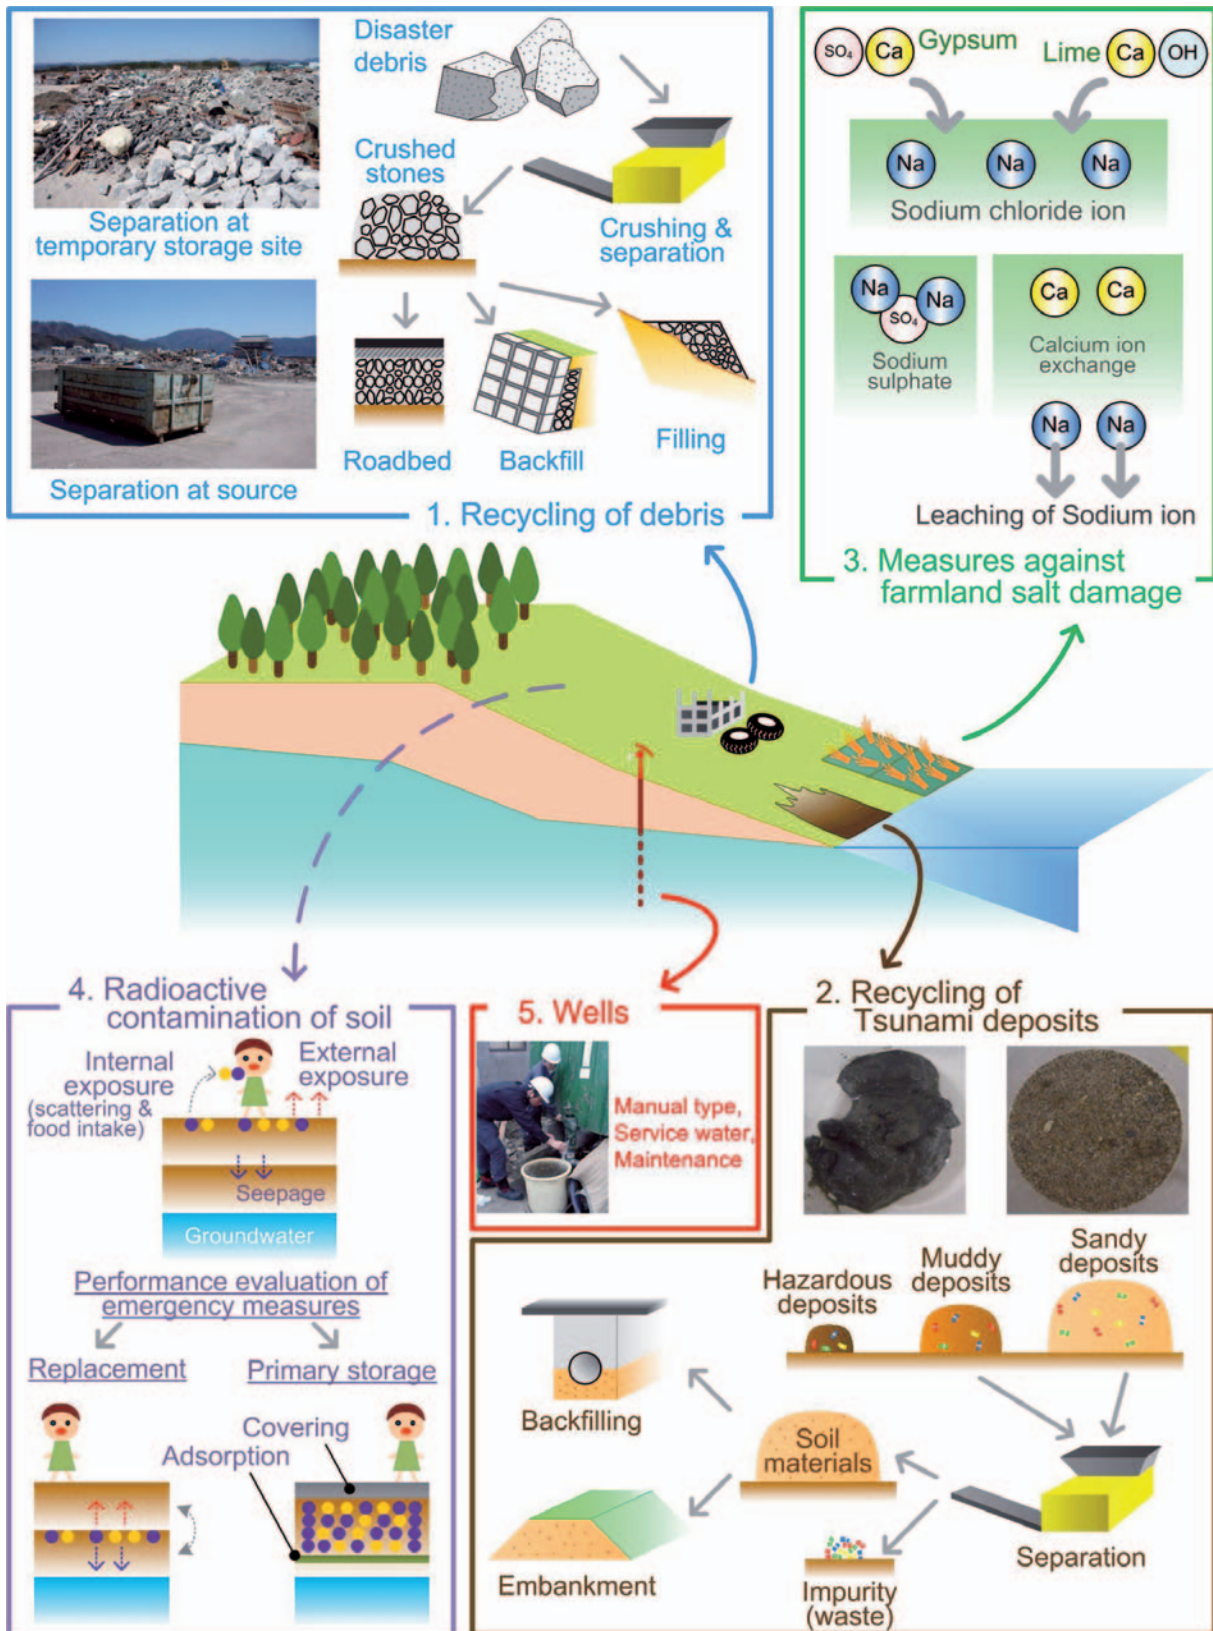
Fig. 3-29 Treatment of disaster wastess, tsunami deposits, and soil contaminated with salt and radioactivity (Endo, K.)

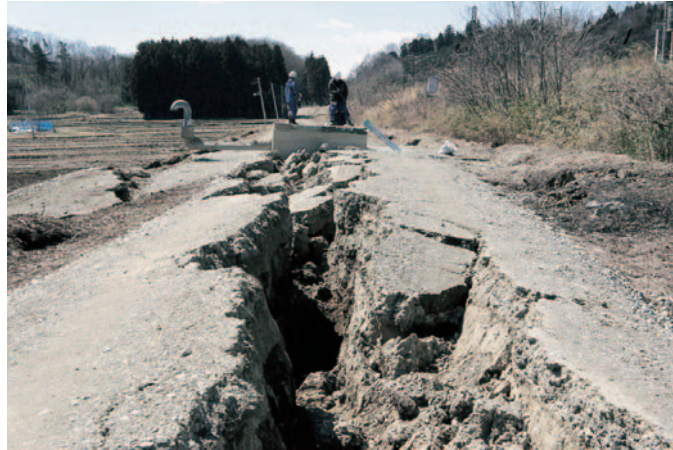
Fig. 3-31 Damage to a main agricultural pipeline for a length of about 1.4 km due to uplift caused by liquefaction of backfill soil. The largest depth of opening was about 1.6 m (Mohri, H.)

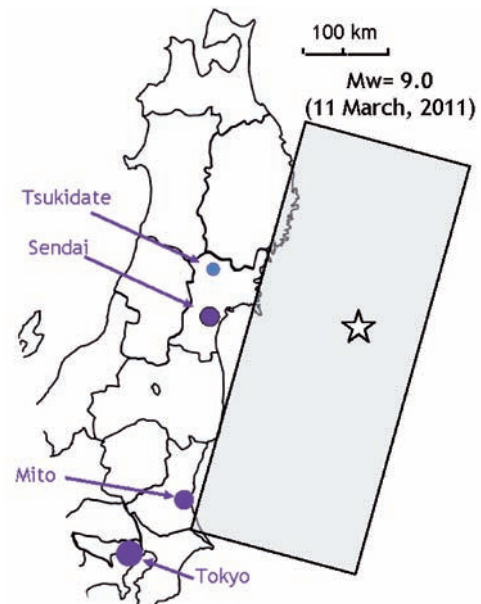
Fig. 1 Location of causative mechanism and major damage areas (Fault model by National Research Institute for Earth Science and Disaster Prevention)

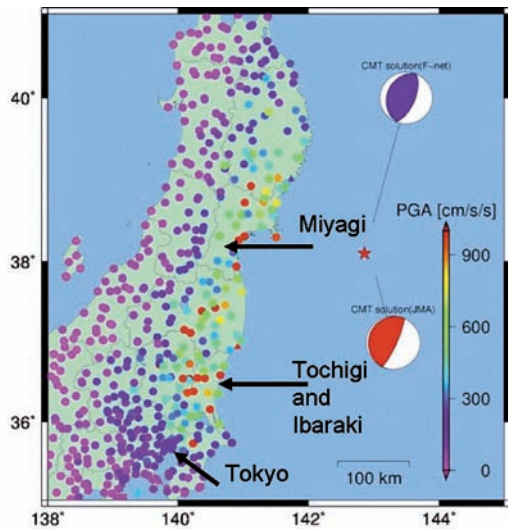
Fig. 3 Distribution of peak ground acceleration provided by NIED, ERI (the University of Tokyo), AIST, and PARI

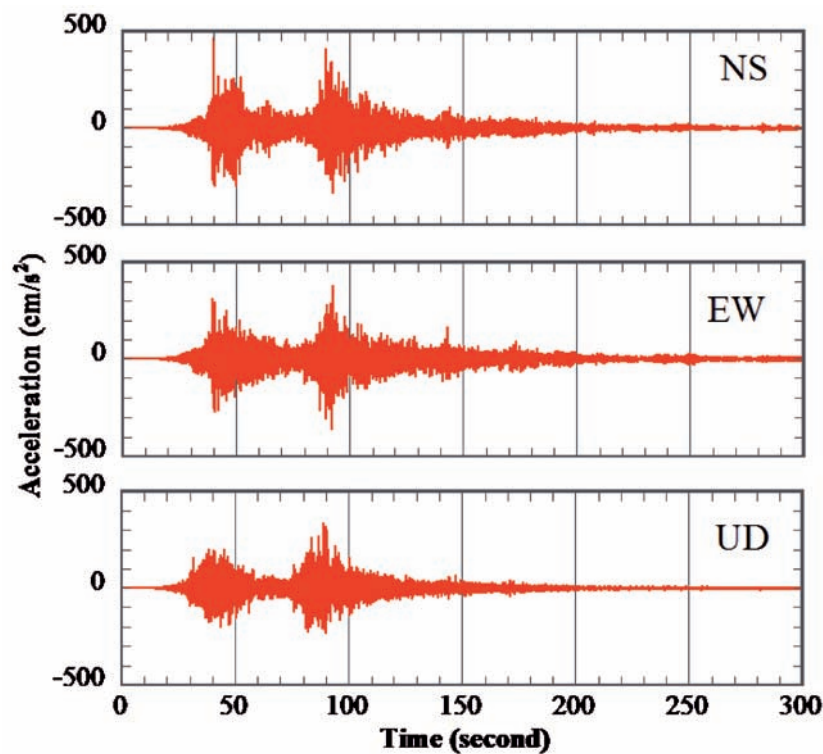
Fig. 5 Strong earthquake motion record at Ishinomaki to the east of Sendai City, Miyagi Prefecture (K-NET MYG010)

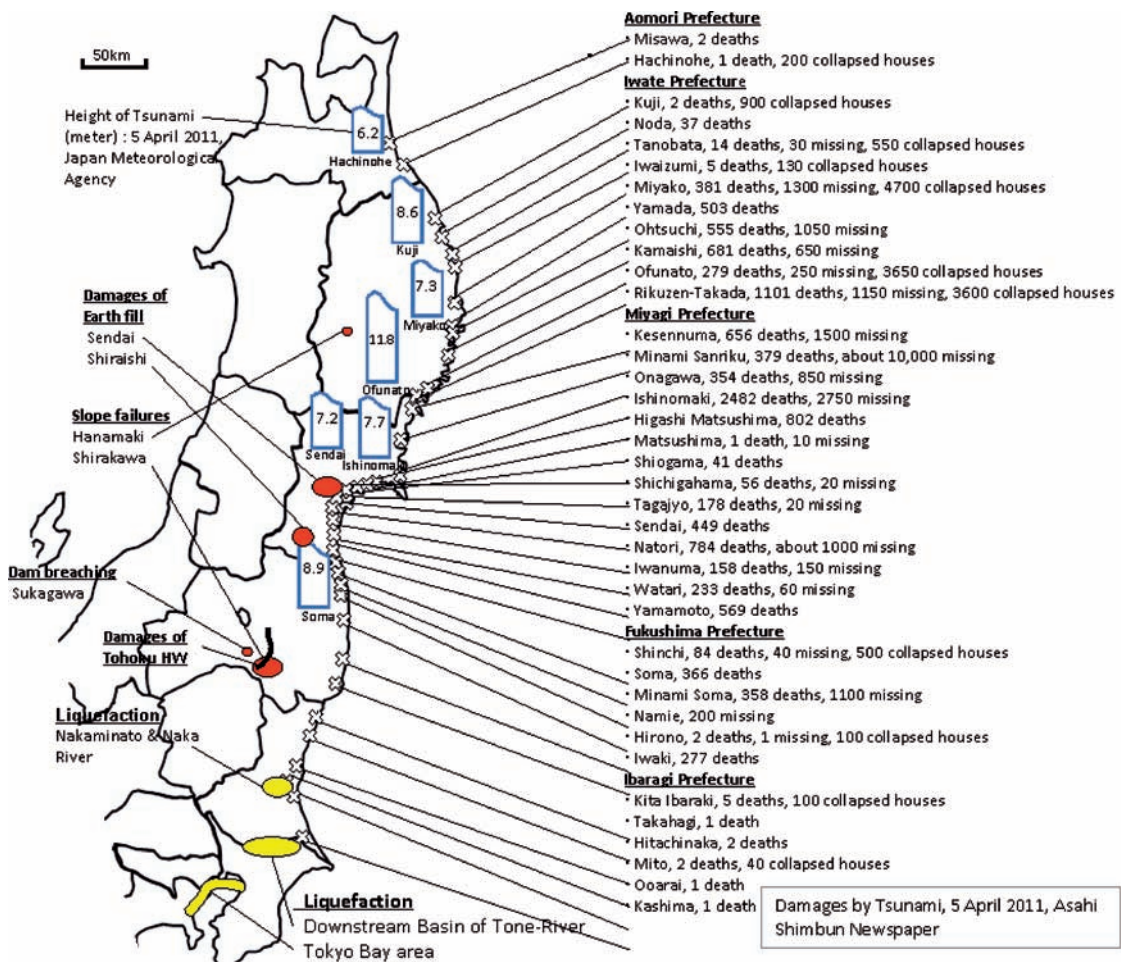
Fig. 6 Distribution of seismic damage

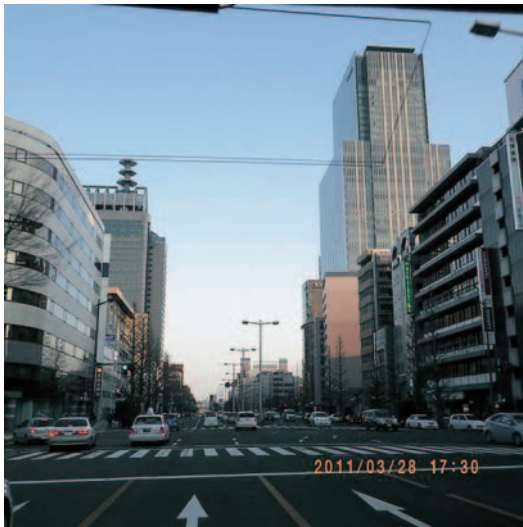
(b) Houses and shops without damage in Tsukidate

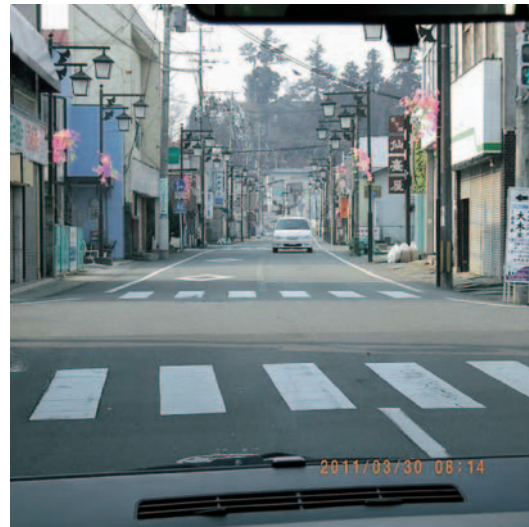
Fig. 7 Good performance of buildings and houses in the affected region

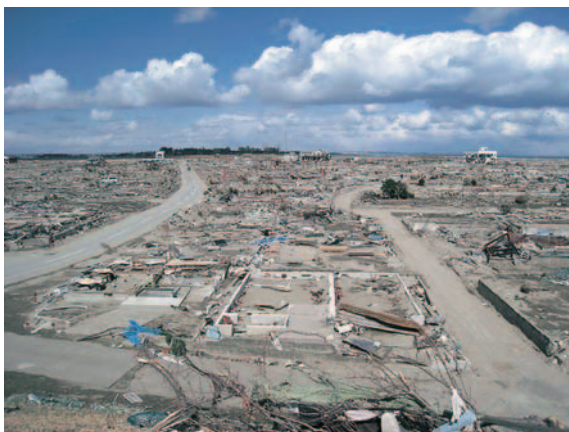
Fig. 8 Yuriage township near Natori River mouth of Sendai (Photo by Daiken Suzuki)

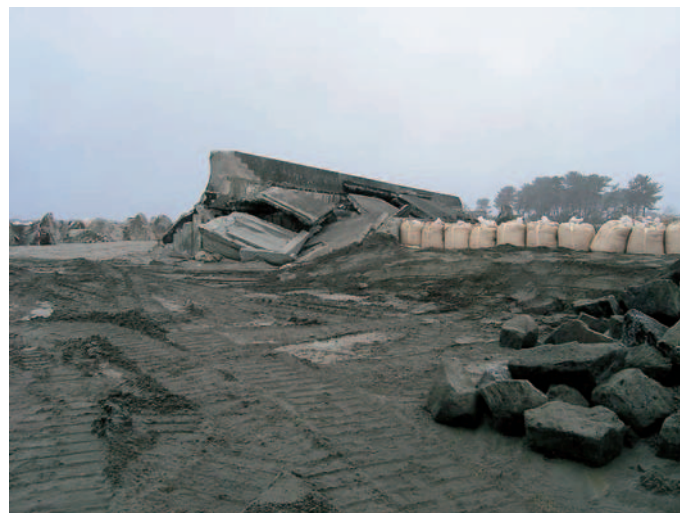
Fig. 13 Destroyed sea wall near Abukuma River mouth
