GEO-HAZARDS DURING EARTHQUAKES AND MITIGATION MEASURES

-LESSONS AND RECOMMENDATIONS FROM THE 2011 GREAT EAST JAPAN EARTHQUAKE-

The Japanese Geotechnical Society

July 2011

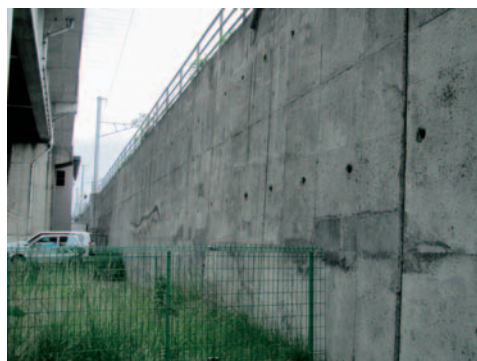
Fig. 2-8 Geosynthetic-reinforced soil retaining wall have a staged constructed full-height rigid facing for Tohoku line (railway), next to Natori River bridge, Sendai City; any damage by this earthquake (photo. by Okamoto, M.)

- b) Geosynthetic-reinforced soil retaining walls having a staged-constructed full-height rigid facing constructed for railways including bullet train lines (Shinkansen) of East Japan Railway (with examples near Sendai, Fig. 2-8, near Ichinoseki, and near Morioka), roads, and bridge abutments, were virtually undamaged and exhibited a good seismic resistance compared with conventional unreinforced embankments. Also, there were examples of geosynthetic-reinforced soil retaining wall constructed for residential areas (Yamamoto Town) that also exhibited good resistance. Moreover, at Tsukue Beach, Tanohata Village, Iwate Prefecture, an unreinforced road embankment was seriously eroded by the tsunami and the top layer of a cut slope above it collapsed. However, a reinforced earth retaining wall on the opposite side was not eroded by the tsunami and was not deformed.

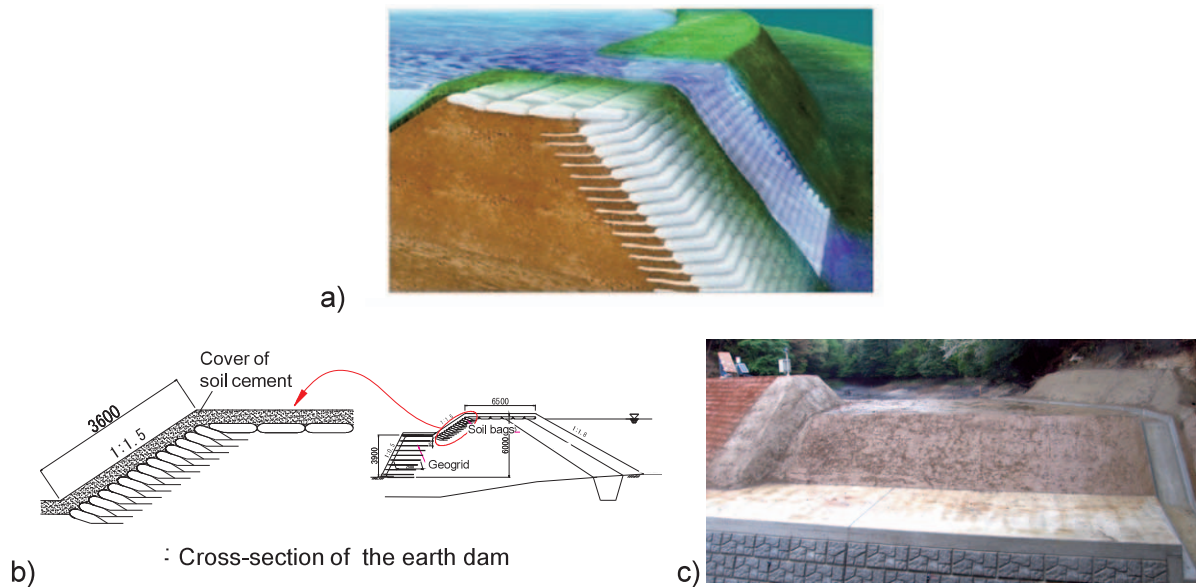
Fig. 2-9 a) artist's view of geosynthetic-reinforced earth dam; and b) & c) restoration of the spillway section of the earth-fill dam of Hirata Ike, Ishikawa Prefecture, that collapsed by the 2007 Noto-Hanto Earthquake (Mohri et al., 2009)

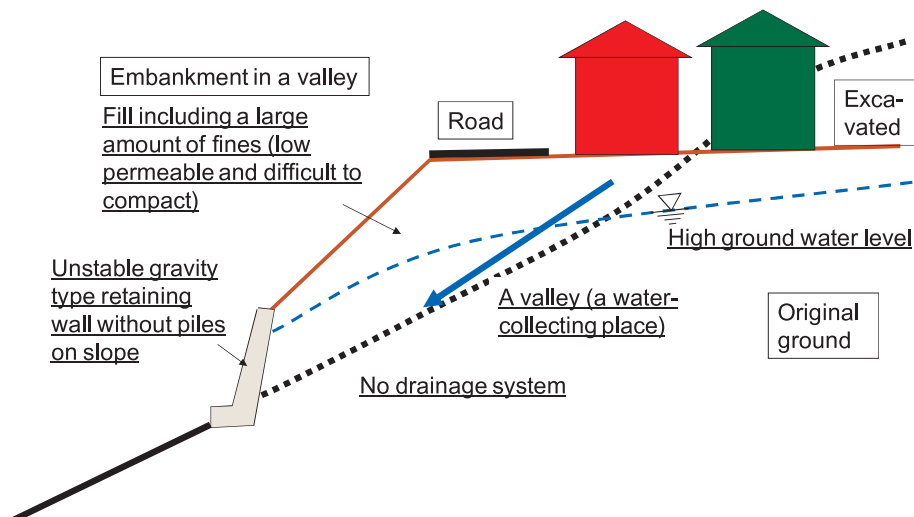
Fig. 3-13 Schematic figure showing several majors causes for the failure of embankment in a valley in a hillside residential area

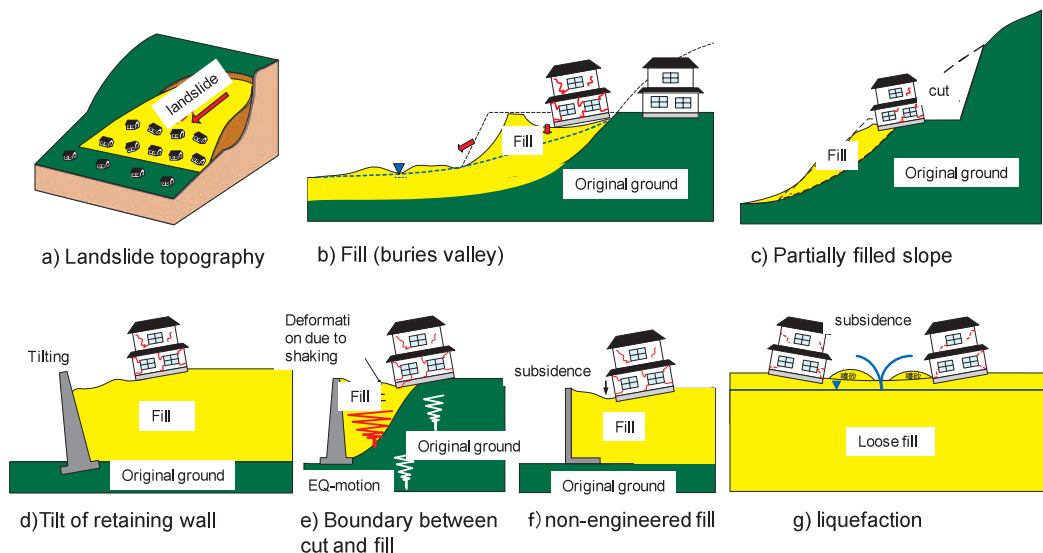
- (2) Normally, the earthquake damage mechanisms affecting residential land developments can be classified into the patterns shown in Fig. 3-15. Of these, there was almost no large scale damage to residential land due to pattern a), where a slip surface in natural ground leads to a landslide. On the other hand, there were many cases of large-scale damage caused by pattern b), where damage takes place near a filled valley. Figure 3-16b shows an example of this damage pattern, where deformation has taken place in proximity to an embankment slope. A photograph was taken near the top of the embankment slope, as seen in the map in Fig. 3-16c. There were also many cases of pattern e), where settlement of an embankment takes place. This is thought to have resulted from the long duration of the seismic motion. The damage due to differential settlement under houses at the boundary between cut and fill was significant.

Fig. 3-15 Classification of damage mechanism of residential fill ground (Kazama, M.)

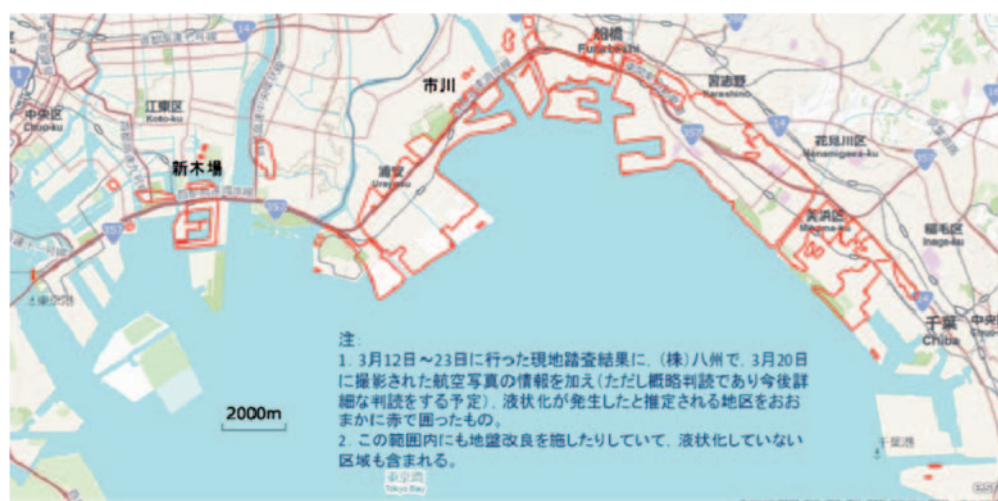
Fig. 3-17 Estimated liquefied zones (delineated by red lines) along Tokyo Bay (Yasuda, S. and Harada, K.)

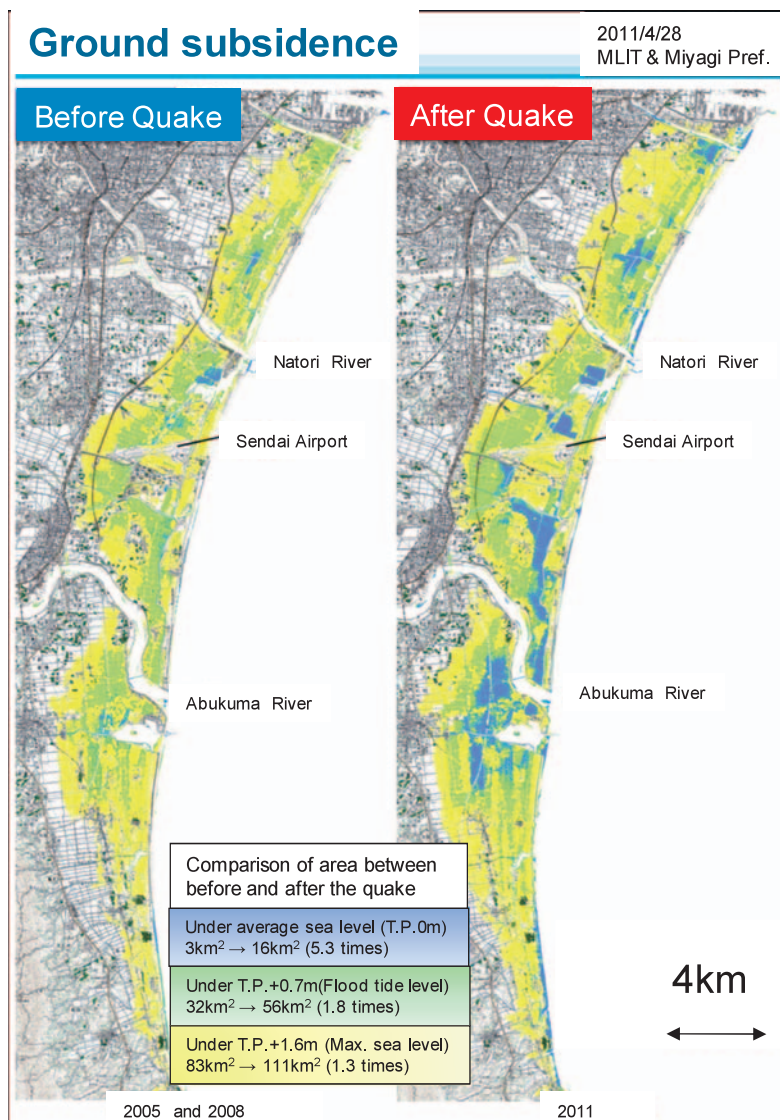
Fig. 3-22 Areas of ground subsidence, South region of Miyagi Prefecture (by the courtesy of Tohoku Regional Bureau of MLIT and Miyagi Prefecture Government)

On the Sendai Plains, the area lying below sea level increased by a factor of 5.3 from 3 km² prior to the earthquake to 16 km² afterwards (Figs. 3-22, 3-23, Table 3-3). As a result of ground subsidence, houses and agricultural land at many places remained flooded even until June 2011, as shown in Fig. 3-24. The subsidence hindered recovery efforts in areas damaged by the tsunami. Work to drain the water was hampered by collapsed coastal dykes or by dykes of insufficient height. Restoration of the coastal dykes will take a long time and until it is complete inundation damage will continue. Further, groundwater is becoming progressively saline as a result of the subsidence, which is causing additional serious problems for the restoration effort.

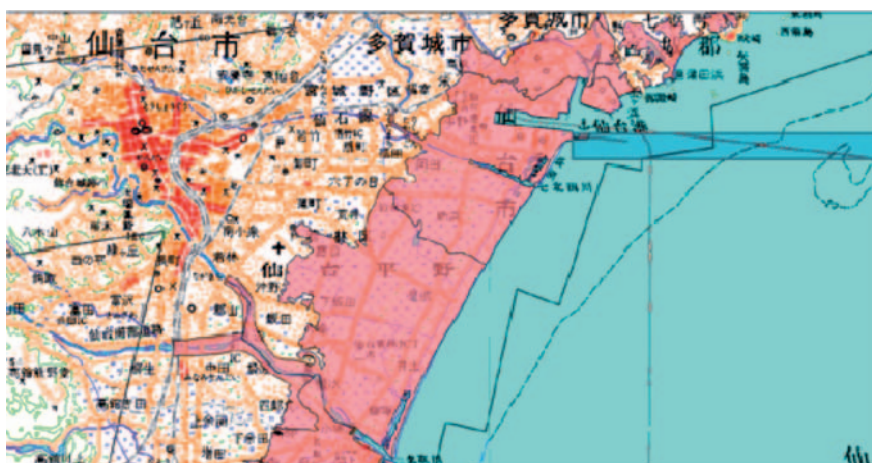
Fig. 3-23 Inundated areas, Sendai Plain (by the courtesy of GSI, Geospatial Information Agency of Japan)

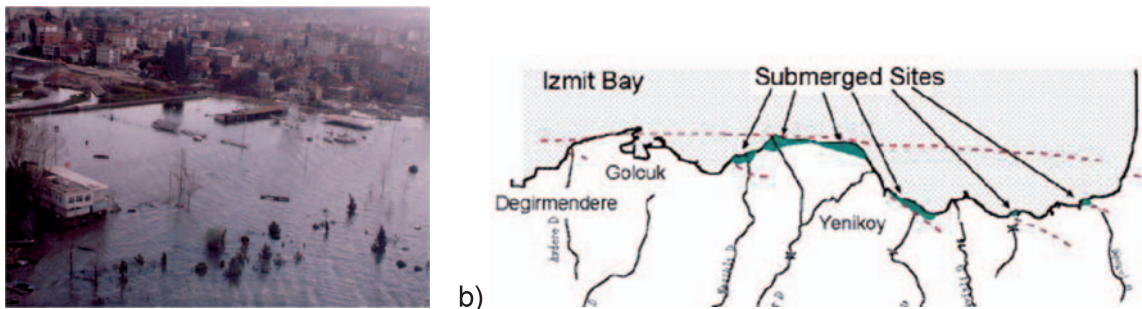
Fig. 3-25 Submerged area in Gölçük due to ground subsidence during the 1999 Kocaeli, Turkey earthquake (Yasuda, S.)

In the 1999 Kocaeli Earthquake in Turkey, ground subsidence occurred over a wide area along the Izmit coast, as shown in Fig. 3-25a, including subsidence of about 1.5 m at Gölçük (Fig. 3-25b) where an area of 1 km² was flooded. The JGS dispatched a survey team to carry out a detailed investigation of the damage, but the mechanism by which the subsidence occurred was not established. Within Japan, also, ground subsidence has previously occurred in many places during past earthquakes. At the time of the Nankai Earthquake there was about 1-1.5 m of subsidence around Kochi City, as shown in Fig. 3-26, and the city suffered flood damage. There is a high possibility of the same type of ground subsidence occurring in future due to the anticipated Nankai, Tonankai, and Tokai earthquakes.

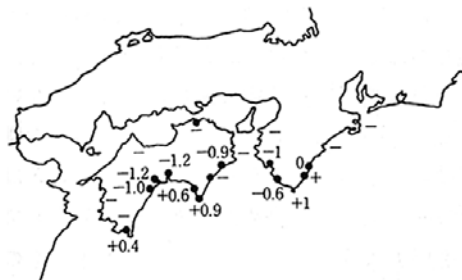
Fig. 3-26 Ground subsidence and heaving (in meter) by the Nankai Earthquake (21th December 1946) (after Kawasumi, Hiroshi)

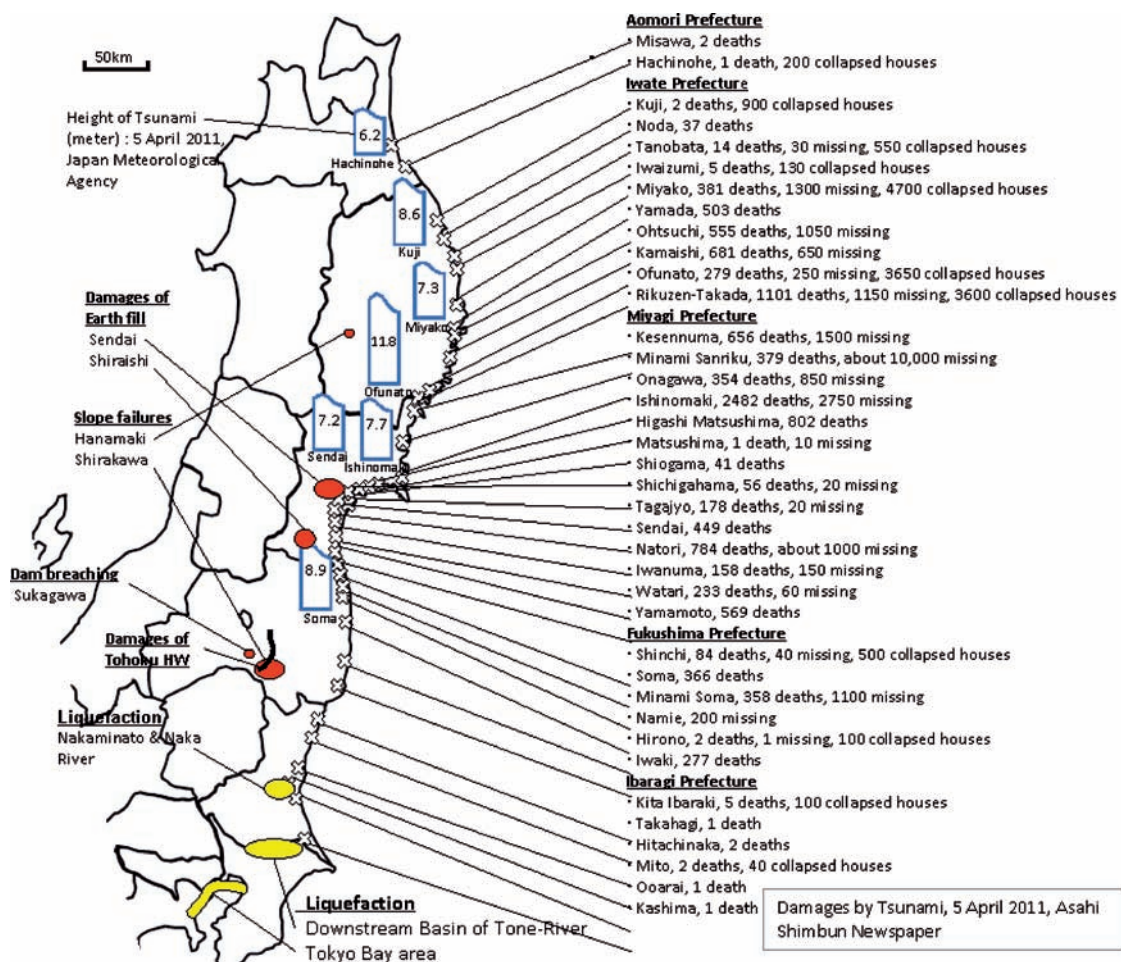
Many kinds of damage were caused by the earthquake over a large area in the eastern part of Japan (Fig. 6), ranging over 500 km in NS direction. The number of victims is not yet finalized in the middle of April because tsunami brought many people into sea and also debris of destroyed houses have made searching very difficult. It is anticipated that the total number

Fig. 6 Distribution of seismic damage

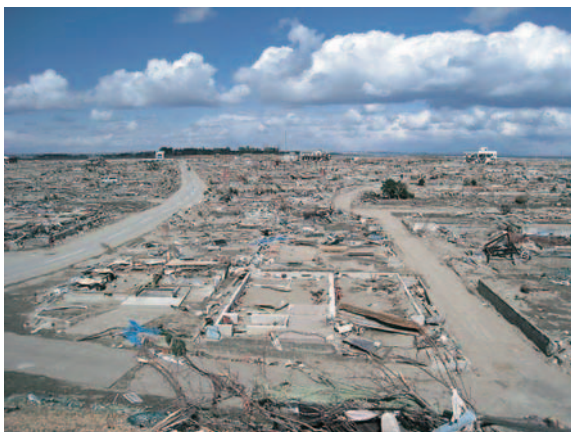
Fig. 8 Yuriage township near Natori River mouth of Sendai (Photo by Daiken Suzuki)

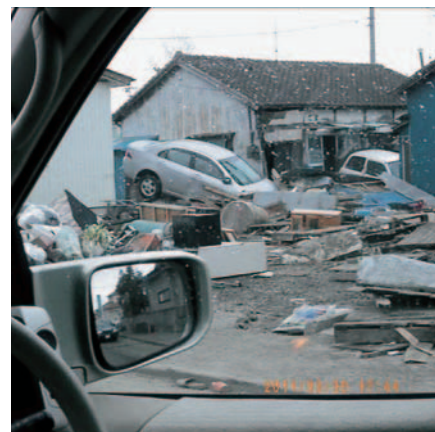
Tsunami was the most serious type of damage. Because of the sympathy to tsunami victims and their families, engineering societies decided to postpone damage reconnaissance in the affected area unless very necessary. There is, however, minimum information available. First, the height of tsunami was investigated to find that the height was more than 15 m and easily overtopped sea walls that had been constructed against the previously known tsunami height. The destructive power of high tsunami was substantial and removed nearly all the structures in the attacked areas (Fig. 8). This photograph reminds us of Banda Aceh after tsunami disaster in 2004. In this flat land, there is no place for people to evacuate, even if a tsunami alert is issued properly. In some tsunami-affected areas, the sea water remained on shore for many hours and evacuation was made impossible. Prof. Nozomu Yoshida of Tohoku Gakuin University had to take refuge on a pedestrian bridge crossing a street for 12 hours without food and warm overcoat, because the street was inundated until 1 AM. There is a huge amount of debris after tsunami attack (Fig. 9). This debris has to be disposed in an appropriate way, which is a very difficult task.

Fig. 9 Tsunami debris in Tagajo to the south Municipality

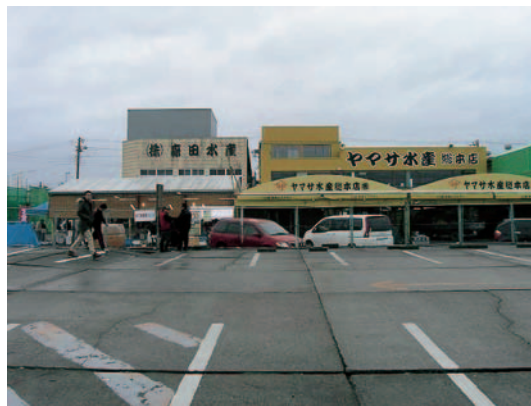
Fig. 12 Resuming business of fish restaurants after tsunami strike (Nakaminato Harbor, Ibaraki)
